The Historical and Architectural
Survey of North Branford

Part B

Prepared by
Totoket Historical Society, Inc.
under the direction of
Frank J. Pannenberg

May 1980

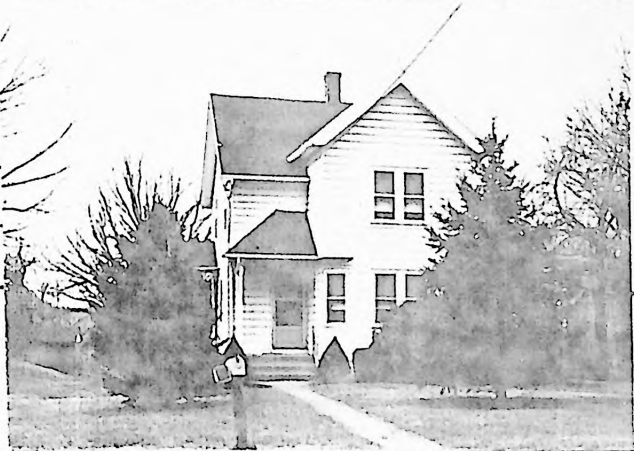
7. STYLE OF BUILDING		DATE OF CONSTRUCTION	
	Victorian		c. 1880	
	8. MATERIAL(S) (Indicate use or location when appropriate)			
<input type="checkbox"/> Clapboard <input type="checkbox"/> Asbestos Siding <input checked="" type="checkbox"/> Brick <input checked="" type="checkbox"/> Other (Specify) Foundation cemented over chimney <input type="checkbox"/> Wood Shingle <input type="checkbox"/> Asphalt Siding <input type="checkbox"/> Fieldstone <input type="checkbox"/> Board & Batten <input type="checkbox"/> Stucco <input type="checkbox"/> Cobblestone <input checked="" type="checkbox"/> Aluminum Siding <input type="checkbox"/> Concrete Type: <input type="checkbox"/> Cut stone Type:

9. STRUCTURAL SYSTEM				
<input checked="" type="checkbox"/> Wood frame <input type="checkbox"/> Post and beam <input checked="" type="checkbox"/> balloon <input type="checkbox"/> Structural iron or steel <input type="checkbox"/> Load bearing masonry <input type="checkbox"/> Other (Specify)

11. NUMBER OF STORIES		APPROXIMATE DIMENSIONS		
2 + attic		31' x 35'		
12. CONDITION (Structural)				
<input checked="" type="checkbox"/> Excellent <input type="checkbox"/> Good <input type="checkbox"/> Fair <input type="checkbox"/> Deteriorated <input checked="" type="checkbox"/> Excellent (Exterior) <input type="checkbox"/> Good <input type="checkbox"/> Fair <input type="checkbox"/> Deteriorated

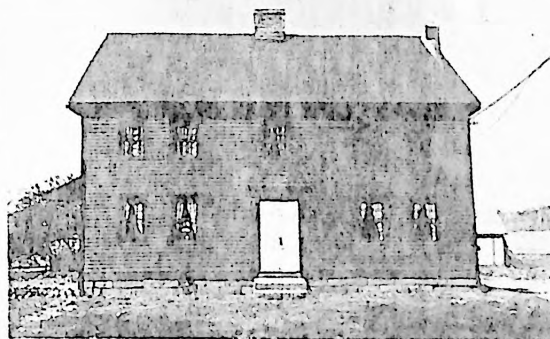
8. MATERIAL(S) (Indicate use or location when appropriate)			
<input checked="" type="checkbox"/> Clapboard	<input type="checkbox"/> Asbestos Siding	<input checked="" type="checkbox"/> Brick	<input type="checkbox"/> Other (Specify)
		Chimney	
<input type="checkbox"/> Wood Shingle	<input type="checkbox"/> Asphalt Siding	<input checked="" type="checkbox"/> Fieldstone	Rear foundation
<input type="checkbox"/> Board & Batten	<input type="checkbox"/> Stucco	<input type="checkbox"/> Cobblestone	
<input type="checkbox"/> Aluminum Siding	<input type="checkbox"/> Concrete Type:	<input checked="" type="checkbox"/> Cut stone Type:	Brownstone front of foundation

11. NUMBER OF STORIES		APPROXIMATE DIMENSIONS	
2 + attic		38' x 28'	
12. CONDITION (Structural)			
<input type="checkbox"/> Excellent	<input type="checkbox"/> Good	<input checked="" type="checkbox"/> Fair	<input type="checkbox"/> Deteriorated
(Exterior)		<input type="checkbox"/> Excellent	<input type="checkbox"/> Good
		<input checked="" type="checkbox"/> Fair	<input type="checkbox"/> Deteriorated

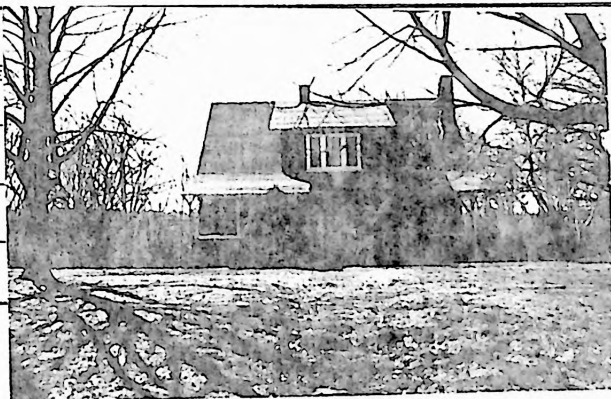
7. STYLE OF BUILDING Bungalow	
DATE OF CONSTRUCTION . 1919	
8. MATERIAL(S) (Indicate use or location when appropriate) <input type="checkbox"/> Clapboard <input type="checkbox"/> Asbestos Siding <input checked="" type="checkbox"/> Brick <input type="checkbox"/> Other (Specify) 1 chimney <input checked="" type="checkbox"/> Wood Shingle <input type="checkbox"/> Asphalt Siding <input checked="" type="checkbox"/> Fieldstone foundation & 1 chimney <input type="checkbox"/> Board & Batten <input type="checkbox"/> Stucco <input type="checkbox"/> Cobblestone <input type="checkbox"/> Aluminum Siding <input type="checkbox"/> Concrete Type: <input type="checkbox"/> Cut stone Type:

11. NUMBER OF STORIES APPROXIMATE DIMENSIONS 2 + attic 20' x 31' + 6' x 20' wing (Main 20' x 24')	
12. CONDITION (Structural) (Exterior) <input type="checkbox"/> Excellent <input checked="" type="checkbox"/> Good <input type="checkbox"/> Fair <input type="checkbox"/> Deteriorated <input type="checkbox"/> Excellent <input checked="" type="checkbox"/> Good <input type="checkbox"/> Fair <input type="checkbox"/> Deteriorated

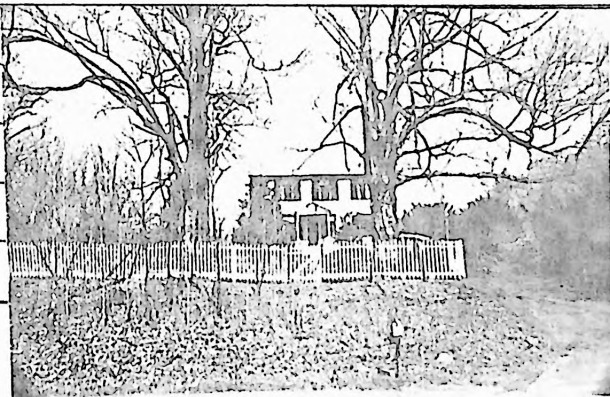
8. MATERIAL(S) (Indicate use or location when appropriate)				
<input type="checkbox"/> Clapboard	<input checked="" type="checkbox"/> Asbestos Siding	<input checked="" type="checkbox"/> Brick	<input type="checkbox"/> Other (Specify)	
	shingles	2 exterior chimneys		
<input type="checkbox"/> Wood Shingle	<input type="checkbox"/> Asphalt Siding	<input checked="" type="checkbox"/> Fieldstone	foundation	
<input type="checkbox"/> Board & Batten	<input type="checkbox"/> Stucco	<input type="checkbox"/> Cobblestone		
<input type="checkbox"/> Aluminum Siding	<input type="checkbox"/> Concrete Type:	<input type="checkbox"/> Cut stone Type:

11. NUMBER OF STORIES		APPROXIMATE DIMENSIONS		
2 + attic		28' front x 22' deep + 12' x 18' wing		
12. CONDITION (Structural)				
<input type="checkbox"/> Excellent	<input type="checkbox"/> Good	<input checked="" type="checkbox"/> Fair	<input type="checkbox"/> Deteriorated	(Exterior)
<input type="checkbox"/> Excellent <input checked="" type="checkbox"/> Good <input type="checkbox"/> Fair <input type="checkbox"/> Deteriorated

DESCRIPTION (Continued)	17 OTHER NOTABLE FEATURES OF BUILDING OR SITE (interior and/or exterior) <ol style="list-style-type: none"> 1. Straight eaves facade faces road-3 bays. Roof overhangs, no returns. 2. Off center entry porch-2 turned columns. 3. West gable window-3/3, east gable window identical to other windows 2/2, though trim clipped at upper corners. 4. Cased posts in corners. Original wide plank flooring in east front room. 4 panel doors. 5. Large barn to east in poor condition. Several sheds. 6. Cast iron gas-light street lamp brought from Baltimore set in yard. 	
	18 ARCHITECT	BUILDER
SIGNIFICANCE	19 HISTORICAL OR ARCHITECTURAL IMPORTANCE <p style="margin-top: 10px;">From old photo (c. 1860, THS files) house originally 1½ storys with small chimney and "stomach" windows. Roof raised to make 2-story house and wings added. Door to left (west) of center (as in old photo).</p>	
SOURCES	Beers Atlas 1868-Hosmer Sperry N. B. Land Records

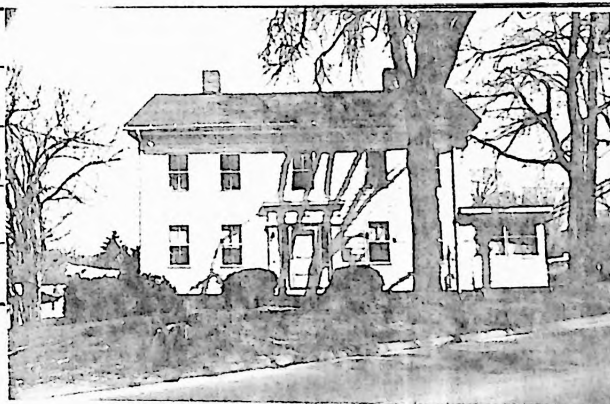
11. NUMBER OF STORIES	APPROXIMATE DIMENSIONS
1 1/2	46' front x 40' deep - irregular on sides (3)
12. CONDITION (Structural)	
<input type="checkbox"/> Excellent <input type="checkbox"/> Good <input checked="" type="checkbox"/> Fair <input type="checkbox"/> Deteriorated	(Exterior)
<input type="checkbox"/> Excellent <input type="checkbox"/> Good <input checked="" type="checkbox"/> Fair <input type="checkbox"/> Deteriorated

DESCRIPTION (Continued)	17 OTHER NOTABLE FEATURES OF BUILDING OR SITE (interior and/or exterior)	
	18 ARCHITECT	BUILDER Fred Barker
SIGNIFICANCE	19 HISTORICAL OR ARCHITECTURAL IMPORTANCE <p>Originally on this site stood a blacksmith's shop built by Newton Stent who followed that trade until his death. (1) Not buried in town. (2) That building stood closer to the present Foxon Road in what is now the front parking area.</p> <p>The store was built and first owned by Mr. Fred Barker, contractor, who lived in the bungalow next door, #243 Foxon Rd., which he also built. Operated by Mrs. Barker, the store originally had a porch and gas pumps at the front. The original, 1925, 18' x 46' structure was built of materials from an old post office that was located across Foxon Rd. The 2/2 windows on the side of the store may be from this post office. The present operator of the store has an old account book from the early days of the store.</p>

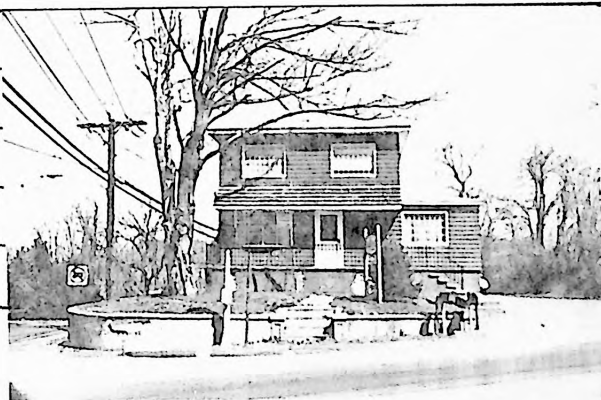
11. NUMBER OF STORIES	APPROXIMATE DIMENSIONS		
2 1/2	13'-11" x 25'-10" Rear Flt., 51'-7" x 28'-5" Main Struct., 18'-3" x 18' East ell at end (cont)		
12. CONDITION (Structural)			
<input type="checkbox"/> Excellent	<input type="checkbox"/> Good	<input checked="" type="checkbox"/> Fair	<input type="checkbox"/> Deteriorated
(Exterior)			
<input type="checkbox"/> Excellent	<input type="checkbox"/> Good	<input checked="" type="checkbox"/> Fair	<input type="checkbox"/> Deteriorated

DESCRIPTION (Continued)	17 OTHER NOTABLE FEATURES OF BUILDING OR SITE (interior and/or exterior)												
	<p>1) The main structure is braced, hewn, timber frame except for alterations c.1880 and later. The rubble stone foundation is faced at the front with cut brownstone. Approximately 2/3 of the foundation forms a full cellar with the other 1/3 on the east left as a crawl space. Large loom built into attic framing.</p> <p>2) The shallow, 35° roof gables face east-west with one central, gable element facing road to south. This front bay projects 3' and was probably built c.1880. Originally, the main roof continued straight. The bay contains 2 symmetrical doors, one at each end, and 6 windows each. The east-west ends each contain 4 windows plus the gable windows. There are two chimneys located on the ridge line approximately 1/3 in from each end.</p> <p>(cont.)</p>												
SIGNIFICANCE	18 ARCHITECTURE	BUILDER											
	<p>19 HISTORICAL OR ARCHITECTURAL IMPORTANCE</p> <p>1) Original appearance is a puzzle at this time. Possibly a pre 1880 photograph will be found.</p> <p>2) Had a front porch along entire front, removed recently.</p> <p>3) Fire occurred in 1930's. Charring can be seen in attic.</p> <p>4) Col. Thaddeus Harrison kept a tavern here for many years.</p> <p>5) Capt. Jerome Harrison, his son, inherited house. The elementary school is named after him. He also donated land for Pare Plain Cemetery.</p>												
SOURCES	<p>Owner - Josephine Musial.</p> <p>Martha Russell's Notes Relating to Early Settlers.</p> <p>County Maps - 1852 - 1856.</p> <p>Beers Atlas Map - 1868</p>												
PHOTO	<p>PHOTOGRAPHER</p> <p>Ruth Arnold</p>	<p>3/79</p>

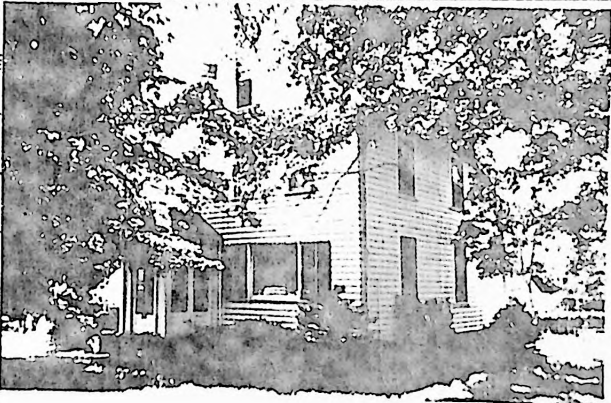
7. STYLE OF BUILDING		DATE OF CONSTRUCTION	
Simplified Queen Anne		c. 1890	
8. MATERIAL(S) (Indicate use or location when appropriate)			
<input type="checkbox"/> Clapboard	<input type="checkbox"/> Asbestos Siding	<input checked="" type="checkbox"/> Brick	<input type="checkbox"/> Other (Specify)
<input checked="" type="checkbox"/> Wood Shingle	<input type="checkbox"/> Asphalt Siding	<input checked="" type="checkbox"/> chimney	
<input type="checkbox"/> Board & Batten	<input type="checkbox"/> Stucco	<input checked="" type="checkbox"/> Fieldstone	foundation
<input type="checkbox"/> Aluminum Siding	<input type="checkbox"/> Concrete Type:	<input type="checkbox"/> Cobblestone	
<input type="checkbox"/> Cut stone	Type:

11. NUMBER OF STORIES		APPROXIMATE DIMENSIONS	
2 + attic		44' x 28' (main 22' x 28') (E11 22' x 11')	
12. CONDITION (Structural)		(Exterior)	
<input checked="" type="checkbox"/> Excellent	<input type="checkbox"/> Good	<input type="checkbox"/> Fair	<input type="checkbox"/> Deteriorated
<input checked="" type="checkbox"/> Excellent	<input type="checkbox"/> Good	<input type="checkbox"/> Fair	<input type="checkbox"/> Deteriorated

DESCRIPTION (Continued)	17 OTHER NOTABLE FEATURES OF BUILDING OR SITE (interior and or exterior)	
	Gable faces road with 3 bay facade, 1/1 windows with tall, narrow 1/1 gable window. Rounded, corner-cut shingles in gable, standard shingles on walls. Enclosed entry porch with scalloped shingles in gable and ornamental, cross bridgework in frieze.	
SIGNIFICANCE	18 ARCHITECT	BUILDER
	19 HISTORICAL OR ARCHITECTURAL IMPORTANCE	
SOURCES	Assessor's Records	
COMPILED BY	PHOTOGRAPHER Ruth Arnold	
	VIEW Front-right	6/79 NEGATIVE ON FILE yes
	NAME Janet S. Grogan	
	ORGANIZATION Totoket Historical Society, Inc.	
ADDRESS P. O. Box 117, Northford, CT 06472

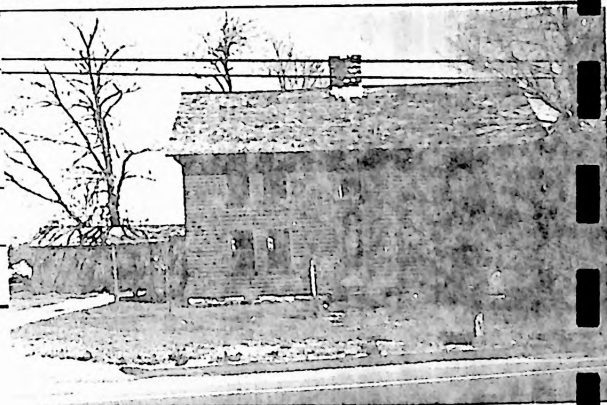
12. CONDITION (Structural)					
<input checked="" type="checkbox"/> Excellent <input type="checkbox"/> Good <input type="checkbox"/> Fair <input type="checkbox"/> Deteriorated <input checked="" type="checkbox"/> Excellent <input type="checkbox"/> Good <input type="checkbox"/> Fair <input type="checkbox"/> Deteriorated (cont.)

DESCRIPTION (Continued)	17 OTHER NOTABLE FEATURES OF BUILDING OR SITE (interior and/or exterior) 1) House was originally or very early built as a saltbox. Rear, central hall (first floor) still retains roof slant in ceiling. 2) Main cornice framing is unique. Four, carved, projecting girts support the wide, 6-1/2" X 14", front plate, extending it almost 10" beyond the house line. 3) A hewn gable overhand extends across the west end of the house but does not show on the east end. 4) Foundation is fieldstone with squared blocks across front. 5) Windows are 12/12 sash. Specially made copies of old existing window in rear of central hall. Original windows were leaded, diamond pane, casement type, 21-3/8" X 29-7/8" outside, with 9 diamond panes. An original casement is boxed and saved in the attic. (cont.)	
	18 ARCHITECT -	BUILDER -
SIGNIFICANCE	19 HISTORICAL OR ARCHITECTURAL IMPORTANCE 1) Trap door in front center hall floor conceals a stone stairway and excavation which was originally used in case Indians burned house. Later was used to hide runaway slaves. 2) House was renovated in early 1800's. Central chimney removed and center hall stairway built. 3) Back ell built about time of Civil War. Original lean-to removed at that time. New lean-to section built on northeast in 1959. House restored by Mr. and Mrs. Doody at this time 1958-59. Chimneys and fireplaces rebuilt using old brick facing. 4) Land is part of 243 acre tract in Bare Plain originally granted to Rev. Samuel Russell, John Palmer and John Linsly, Sr. on Feb. 2, 1696-97. In 1699 John Linsey (probably grandson to above) bought 1/3 of Russell's share and built house. He married Mary Harrison, June 6, 1699. He died 1748 leaving house to son John. This son left property to (cont.)

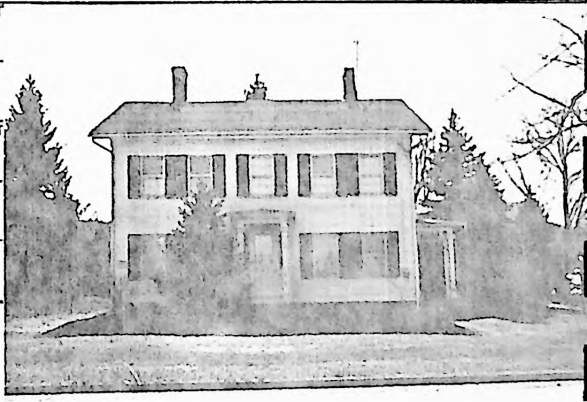
12. CONDITION (Structural)				
<input type="checkbox"/> Excellent <input checked="" type="checkbox"/> Good <input type="checkbox"/> Fair <input type="checkbox"/> Deteriorated <input type="checkbox"/> Excellent <input checked="" type="checkbox"/> Good <input type="checkbox"/> Fair <input type="checkbox"/> Deteriorated

DESCRIPTION (Continued)	17 OTHER NOTABLE FEATURES OF BUILDING OR SITE (interior and/or exterior)		
	<ol style="list-style-type: none"> 1) Back step was original kitchen fireplace hearthstone. 2) Original fireplace and attached beehive oven were removed from sink room at time of kitchen remodelling. 3) Original mantle in Dining Room and Bed Room. 4) Upstairs - original cheese room size of large closet. Shelves all around. 5) Roof structure has two large, hewn purlin beams running the width of the house tying together the 4 main trusses. 		
SIGNIFICANCE	18 ARCHITECT	BUILDER Edward Linsley	
	19 HISTORICAL OR ARCHITECTURAL IMPORTANCE <ol style="list-style-type: none"> 1) House was owned and occupied from the time of completion, by three generations of Linsleys. 2) It was sold to settle the estate of Lucinda Linsley who died in May, 1929. Mr. and Mrs. John Doody bought it on their marriage in August, 1929. 3) Old spidery, undated original floor plan and list of timber used is available. 4) House was built by Edward, son of Isaac Linsley. 5) Edward Linsley 1804-1875.

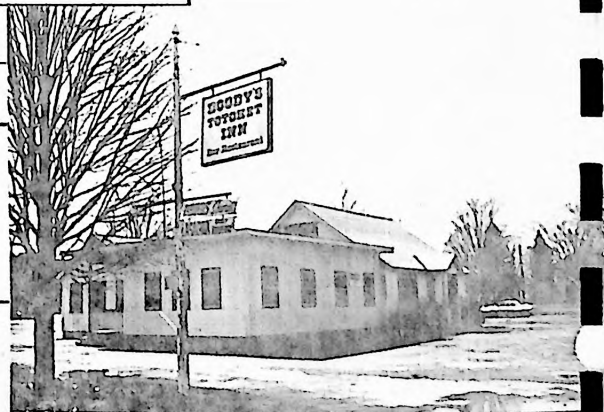
DESCRIPTION (Continued)	17 OTHER NOTABLE FEATURES OF BUILDING OR SITE (interior and or exterior) Large wooden (electrified) cross was located at top of hill to rear of building approx. 1/2 mi. Was built by Atwater and maintained by Lyons Club. Was in memory of son of Francis P. Doody who died on Mount Everest.		
SIGNIFICANCE	18 ARCHITECTY none		BUILDER Fred Barber and others.
	19 HISTORICAL OR ARCHITECTURAL IMPORTANCE 1) First restaurant liquor license in North Branford. 2) First union organization for N. H. Trap Rock Co. took place here in 1950's. 3) Democratic Party meetings held here. 4) The North Branford Lyons Club chartered here and met for years. The Guilford Archery Club " " " " " " 5) Many other club meetings and social events have taken place here. The establishment has become something of an institution in town.		
SOURCES	Francis P. Doody - Owner.		
PHOTO	PHOTOGRAPHER Ruth Arnold		DATE 4/79

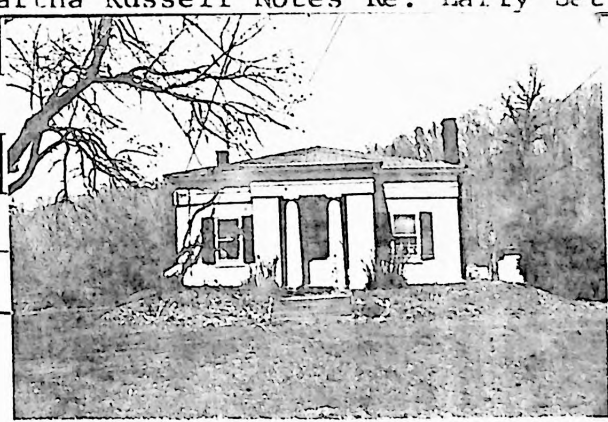
11. NUMBER OF STORIES			
1 1/2			
APPROXIMATE DIMENSIONS			
31' x 33' (1054 sq. ft.) - Shed 20' x 14' (280 sq. ft.)			
12. CONDITION (Structural)			
<input type="checkbox"/> Excellent	<input type="checkbox"/> Good	<input checked="" type="checkbox"/> Fair	<input type="checkbox"/> Deteriorated
(Exterior)			
<input type="checkbox"/> Excellent	<input type="checkbox"/> Good	<input checked="" type="checkbox"/> Fair	<input type="checkbox"/> Deteriorated

DESCRIPTION (Continued)	17 OTHER NOTABLE FEATURES OF BUILDING OR SITE (interior and/or exterior)	
	<ol style="list-style-type: none"> 1. Small but monumental house set upon a man made 4' earth platform. 2. Projecting, recessed entrance containing two fluted Doric columns (no plinths) resting directly on stone base. Doorway has side lights of four rectangular panes and a single panel door. Tall, shelved closets on each side of door in portico ends. 3. Broad entablature runs the circumference of the building, including the portico. It is composed of a plain architrave and frieze, separated by a narrow band of molding. 4. According to former owner, Mrs. Daniel M. Doody, there was an approx. 1' - 1½' frieze board above the cornice mounted on roof. (Cont.) 	
SIGNIFICANCE	18 ARCHITECT Attributed to Ithiel Town	BUILDER
	19 HISTORICAL OR ARCHITECTURAL IMPORTANCE <ol style="list-style-type: none"> 1. On the National Register of Historic Places - 1977, Nomination Form by Conn. Historical Commission. May 12, 1976. Only building in this survey to have this designation at this time. 2. Was earlier house on this site built by Micah Palmer. 3. Micah Baldwin, New York merchant, built present house and gave it to nephew George S., son of Josiah Baldwin. George's daughter Elizabeth with husband Seth Russell then lived in house. 4. The 1958 HABS sheet gives it the name - Lydia Russell House - incorrectly. 5. Has been included on Conn. Statewide Inventory of Historic Resources, 1975 - Conn. Historical Commission. (Cont.)

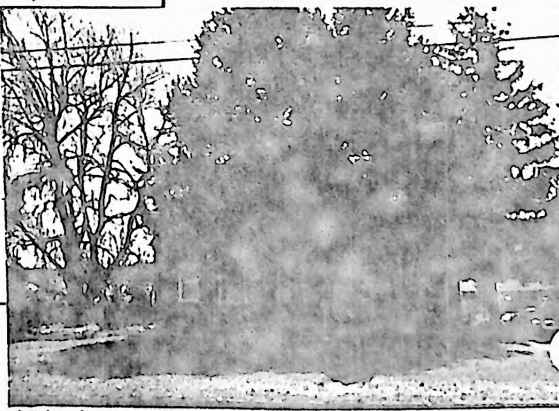
11. NUMBER OF STORIES		2 and small attic	
12. CONDITION (Structural)		<input type="checkbox"/> Excellent <input checked="" type="checkbox"/> Good <input type="checkbox"/> Fair <input type="checkbox"/> Deteriorated

DESCRIPTION (Continued)	17 OTHER NOTABLE FEATURES OF BUILDING OR SITE (interior and or exterior)			
	1) Has had many small-scale alterations over the years. 2) Original clapboards covered over. 3) Owner believes it had taller first floor windows at the front at an earlier time. 4) Is still operated as farm.			
SIGNIFICANCE	18 ARCHITECT		BUILDER	
	19 HISTORICAL OR ARCHITECTURAL IMPORTANCE House built by William J. Benton. He bought portion of Rufus Rodgers farm.			
SOURCES	Rita Shapiro Burs Atlas Map - 1868. Notes to early settlers of North Branford - Martha Russell.			
COMPILED BY	PHOTOGRAPHER		DATE	
	Ruth Arnold		5/78	
	VIEW	NEGATIVE ON FILE		
	Front	X		
	NAME		DATE	
Frank Pannenburg		9/18/79		
ORGANIZATION				Place Photograph
Totoket Historical Society, Inc.				
ADDRESS				
P.O. Box 117, Northford, CT 06472

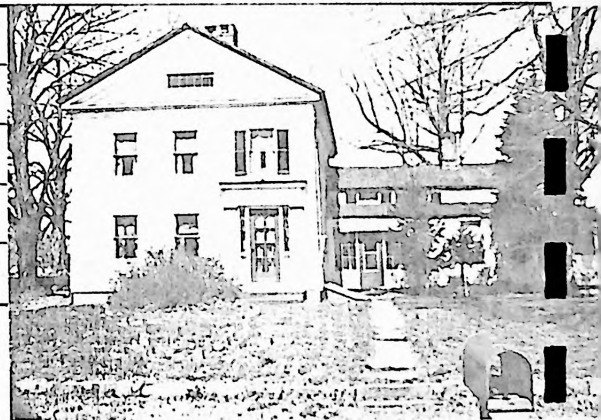
11. NUMBER OF STORIES	APPROXIMATE DIMENSIONS
2 + attic	Main House 24½' X 30½' / Side Ell 32' X 19' / Rear Ell 15' X 23'
12. CONDITION (Structural)	(Exterior)
<input type="checkbox"/> Excellent <input type="checkbox"/> Good <input type="checkbox"/> Fair <input checked="" type="checkbox"/> Deteriorated	<input type="checkbox"/> Excellent <input type="checkbox"/> Good <input type="checkbox"/> Fair <input checked="" type="checkbox"/> Deteriorated

1) As a result of it's general lack of attention, this house stands historically much more intact than most other Greek Revival homes in area. No running water and no toilets in main house. Severe dry rot in basement beams.

2) House stands where older house (moved across street) once stood. Owner of original house was Thomas Goodsell.			
SOURCES	1) Present tenant 2) Howard Krom, Realtor 3) County Maps 1852-1856 4) Beers Atlas - 1968. 5) Martha Russell's Notes Relating to Early Settlers		
PHOTO	PHOTOGRAPHER		DATE
	Ruth Arnold		4/78
COMPILED BY	VIEW		NEGATIVE ON FILE
	North - front		Yes
	NAME		DATE
	Frank J. Pannenberg		Oct. 28, 1979
ORGANIZATION			
Totoket Historical Society, Inc.			
ADDRESS			
F.O. Box 117, Northford, CT 06472			
20 SUBSEQUENT FIELD EVALUATIONS			
21 THREATS TO BUILDING OR SITE			
<input type="checkbox"/> None known <input type="checkbox"/> Highways <input type="checkbox"/> Vandalism <input type="checkbox"/> Developers <input checked="" type="checkbox"/> Other <u>Demolition</u>			
<input type="checkbox"/> Renewal <input type="checkbox"/> Private <input checked="" type="checkbox"/> Deterioration <input type="checkbox"/> Zoning <input type="checkbox"/> Explanation

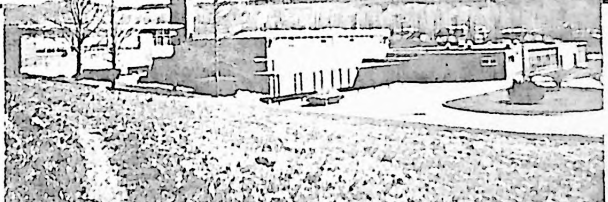
COMPILED BY	PHOTO	PHOTOGRAPHER Ruth Arnold	DATE 12/79	
	VIEW	Southwest - Front	NEGATIVE ON FILE Yes	
		NAME	Frank J. Pannenberg	DATE 11/13/79
		ORGANIZATION	Totoket Historical Society, Inc.	
ADDRESS		P.O. Box 117, Northford, CT 06472		
Place Photograph Here

DESCRIPTION (Continued)	17 OTHER NOTABLE FEATURES OF BUILDING OR SITE (interior and or exterior)			
SIGNIFICANCE	18 ARCHITECT	original building & additions Schilling & Goldbecker	BUILDER Giordano Construction - Pranford	
	19 HISTORICAL OR ARCHITECTURAL IMPORTANCE			
1) Name changed in 1971, was formerly North Branford Junior High School. 2) Reflects the exploding growth of North Branford in the 1950's and 60's.				
SOURCES	1) George Gallager 2) North Branford Board of Education 3) Herbert Noyes, Architect, Guilford 4) North Branford Assessor's Office

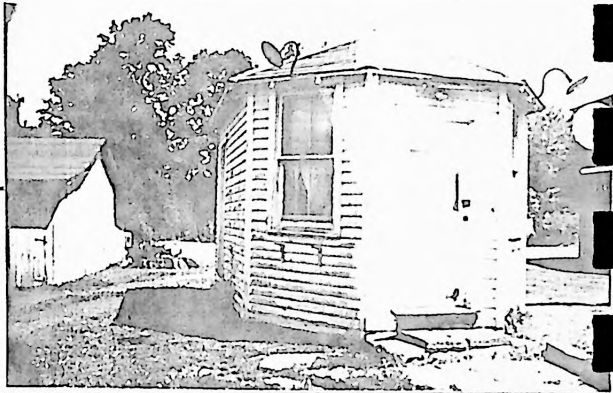
PHOTO	PHOTOGRAPHER	DATE
	Ruth Arnold	5/79
COMPILED BY	VIEW	NEGATIVE ON FILE
	Gas station - front	Yes
	NAME	DATE
	Frank J. Pannenberg	10/2/79
	ORGANIZATION	
	Totoket Historical Society, Inc.	
	ADDRESS	
	P.O. Box 117, Northford, CT 06472

12. CONDITION (Structural) (Exterior)				
<input type="checkbox"/> Excellent <input checked="" type="checkbox"/> Good <input type="checkbox"/> Fair <input type="checkbox"/> Deteriorated <input type="checkbox"/> Excellent <input checked="" type="checkbox"/> Good <input type="checkbox"/> Fair <input type="checkbox"/> Deteriorated

DESCRIPTION (Continued)	17 OTHER NOTABLE FEATURES OF BUILDING OR SITE (interior and/or exterior)	
	1) Gable not facing road. Central dormer on front with single, sloped plane roof. 2) Glassed in porch across entire front of house, 2/2 storm windows. 3) Exposed rafter ends. 4) Brown stained shingle siding with white trim on house. White clapboard on gas station. 5) 1/1 sash on house, 2/2 on porch, both types on gas station. 6) Two electric lights with porcelain shades are mounted with gooseneck conduit supports just under the two angled front roofs of the gas station. 7) Both buildings relatively unchanged from 1930's.	
SIGNIFICANCE	18 ARCHITECT	BUILDER
	19 HISTORICAL OR ARCHITECTURAL IMPORTANCE	
SOURCES	1) One of the first gas stations in North Branford. Had two hand operated pumps. Atlantic Gasoline. The present tenant in the house operated the gas station for one year, 1936 (Mr. Thomas Colter). He believes the gas station began operation in 1931 or 1932. 2) It is the combined effect of these two small buildings that gives interest. One's imagination can easily picture cars with running boards and rumble seats driving up.

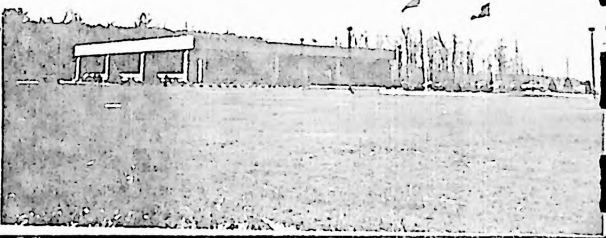
PHOTO	PHOTOGRAPHER Ruth Arnold		DATE 12/79
	VIEW Northeast	NEGATIVE ON FILE Yes	
COMPILED BY	NAME Frank J. Pannenberg		DATE 10/4/79
	ORGANIZATION Totoket Historical Society, Inc.		
	ADDRESS P.O. Box 117, Northford, CT 06472		
Place Photograph Here

SIGNIFICANCE	18 ARCHITECT Kaestle and Boos Associates	BUILDER Tilcon-Tomasso acted as own contractor.	
	19 HISTORICAL OR ARCHITECTURAL IMPORTANCE		
<p>1) An example of an industry taking extra care to design a corporate headquarters in a manner responsible to the community.</p>			
SOURCES	<p>Tilcon-Tomasso President's Office</p> <p>E. Robert Gregan, Landscape Architect</p>

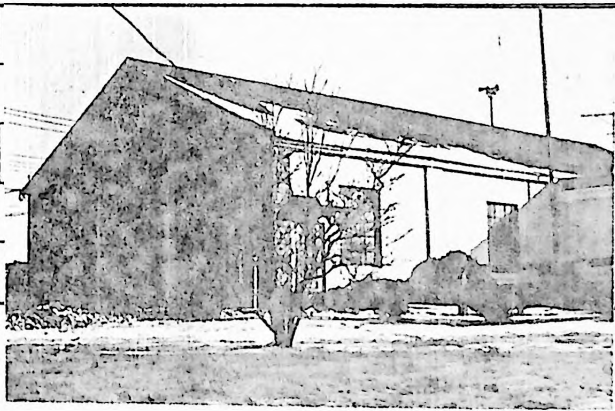
DESCRIPTION (Continued)	17 OTHER NOTABLE FEATURES OF BUILDING OR SITE (interior and or exterior) <ol style="list-style-type: none"> 1. 3 bay - holds 6 pieces of apparatus. 2. Rec. room in attic over kitchen & rear. 3. Land belongs to Tilcon - Tomasso (New Haven Trap Rock) - Co. #1 holds 99 year lease at \$1.00 per year. 	
	18 ARCHITECT Volunteer fire men	BUILDER Volunteer fire men
SIGNIFICANCE	19 HISTORICAL OR ARCHITECTURAL IMPORTANCE <ol style="list-style-type: none"> 1. First fire station in town. 2. Company #1 was original fire company in North Branford, organized 1938, protected both districts until Company #2 was formed in 1945. 3. Building designed and built by volunteer firemen. Masonry work was done by Mattie & Son. 4. Famous story in town is that after acquiring the first fire truck in 1939, the first fire call was to the house of the woman who protested most vehemently at a town meeting against the purchase of the truck.

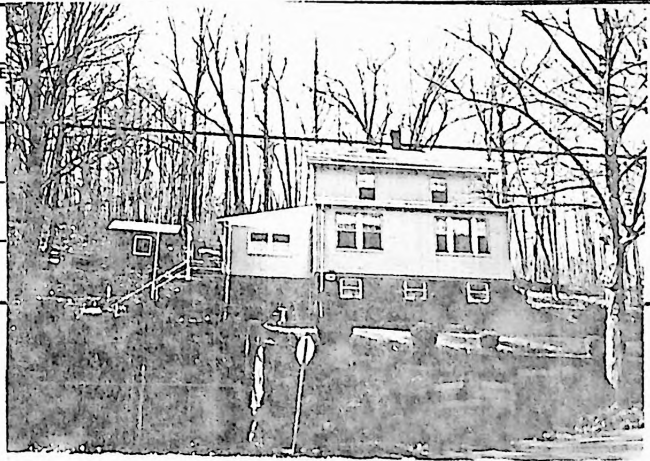
Ruth Arnold 5/79			
	VIEW	NEGATIVE ON FILE		
	Front	yes		
	NAME	Janet Grogan 2/13/80

DESCRIPTION (Continued)	17 OTHER NOTABLE FEATURES OF BUILDING OR SITE (interior and/or exterior)		1. Basement foundation exposed in front - functions as part of living area. 2. Fireplace in basement - unusable. 3. Two car garage is under hill at street level. 4. Medium roof overhang, 1' ±, no cornice returns. 5. Original entry covered by south west addition.	
	18 ARCHITECT		BUILDER	
			Charles Frisbie	
	19 HISTORICAL OR ARCHITECTURAL IMPORTANCE			
	SIGNIFICANCE		House built by Charles Frisbie, son of Levi Frisbie - Stony Creek. He married Mary, daughter of Jonathan, son of Samuel & Lydia (Baldwin) Foot. Sold place to Jane Wheaton, daughter of Abram Wheaton c. 1875*.	
SOURCES	Assessors record - 20 - 1 Beers Atlas - 1868. Owner - Mrs. Allen *Martha Russell's notes relating to Early Settlers.			
COMPILED BY	PHOTOGRAPHER

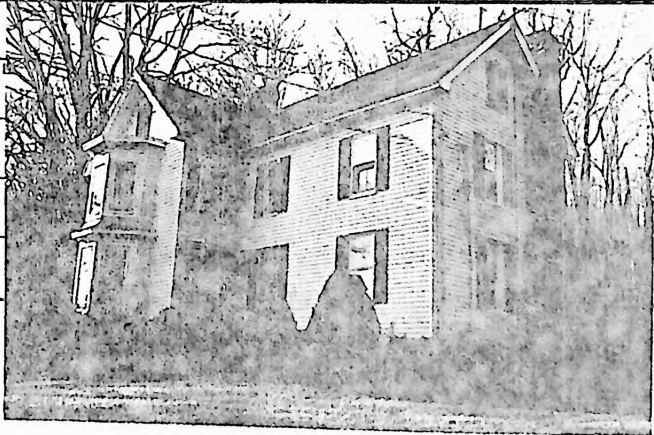
Right front		
	NAME		
	Janet Gegan 1/80		
	ORGANIZATION		
	Totoket Historical Society, Inc.		
	ADDRESS

DESCRIPTION (Continued)	17 OTHER NOTABLE FEATURES OF BUILDING OR SITE (interior and/or exterior)		
	1. The original clapboards are on rear of house with a 3 row scalloped shingle border under eaves. Gable end is also scalloped shingles. 2. Large barn is portion of original large dairy barn. Part of the cut stone foundations still exist. 3. Cut stone retaining wall supports sloped roof of attached garage. Cedar posts also serve as supports. 4. Original cut granite fireplace in front room. 5. Original floors, doors, door and window casings. 6. Two story bay window. (Cont.)		
SIGNIFICANCE	18 ARCHITECT	BUILDER	
	By/for Charles Gedney		
	19 HISTORICAL OR ARCHITECTURAL IMPORTANCE

1. By/for Charles Gedney 2. Built on site of Charles Cooper's Blacksmith Shop, erected 1836.		
SOURCES	Martha Russell's Notes Assessor's record 20-2 Owner - Mr. Cowan Grandson of original owner, Mr. Gedney		
PHOTO	PHOTOGRAPHER		NEGATIVE ON FILE
	Ruth Arnold 1/80		
COMPILED BY	VIEW

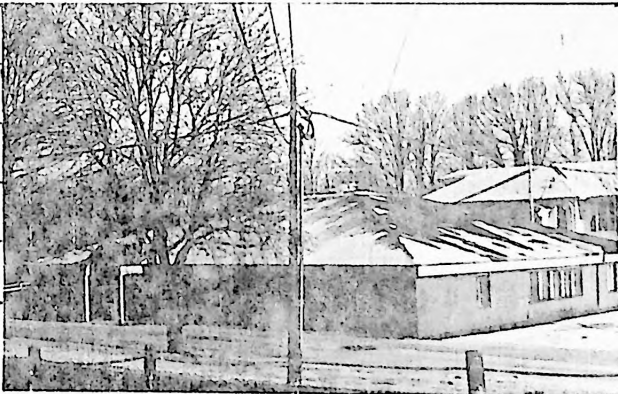
DESCRIPTION (Continued)	17 OTHER NOTABLE FEATURES OF BUILDING OR SITE (interior and/or exterior)		1. Central reception area - 2 story pyramidal ceiling with 6' sq. skylight at apex. 2. Oak kick boards on doors. 3. Large oak reception counter. 4. Recessed and indirect lighting. 5. Use of curved walls to direct circulation. 6. Some walls are carpeted.
	SIGNIFICANCE	SOURCES	<div style="display: flex; justify-content: space-between;"> <div style="width: 45%;"> 18 ARCHITECT Caswell Cooke </div> <div style="width: 45%;"> BUILDER Almar Construction Co. </div> </div> <div style="margin-top: 10px;"> 19 HISTORICAL OR ARCHITECTURAL IMPORTANCE First building to be built specially for use as Town Administration Building. Building was built with funds granted by the Community Development Act, Public Works' Grant. Sits on original site of Zion Church - moved 1957. Land originally belonged to John Harrison who came to "North Farms" in 1707. </div> <div style="margin-top: 20px;"> Town Managers Office Assessor's records Martha Russell's "Notes on Early Settlers". </div>

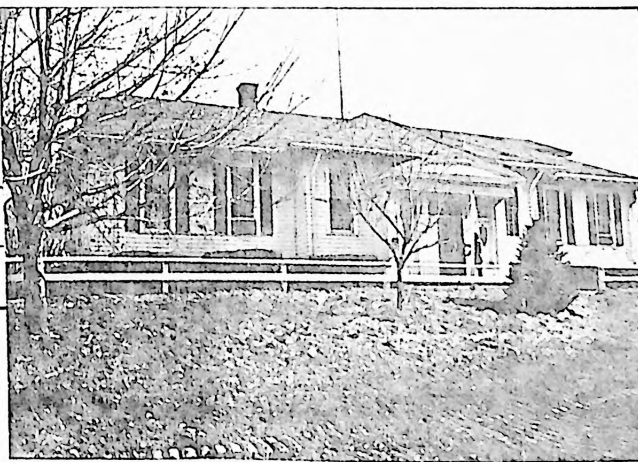
DESCRIPTION (Continued)	17 OTHER NOTABLE FEATURES OF BUILDING OR SITE (interior and/or exterior)		<p>Originally built as a three room school, it has maple flooring, chestnut woodwork and solid birch paneled doors. The ceilings are pressed metal. Porticol entrance has segmental arch classical in feeling. There is evidence that there were cylindrical columns. 20" dia., placed one on either side. Craftsmen style with exposed ornamental rafter ends and wooden gutters. Two dormers, one on each end of roof, have wide overhangs and ornamental brackets.</p> <p>There is a subtle flair where the shingles meet the cobblestone foundation. Interior alterations consist of adding interior walls to make office space, putting a women's bathroom in the cloakroom, and changing the stairway. The basement has been divided into offices and a mens room.</p>																
	SIGNIFICANCE	18 ARCHITECT	<table border="1" style="width:100%; border-collapse: collapse;"> <tr> <td style="width:50%;">William E. Becroft of Wallingford</td> <td style="width:50%;">BUILDER O. C. Kelsey (bid \$11,945)</td> </tr> </table> <p>19 HISTORICAL OR ARCHITECTURAL IMPORTANCE</p> <p>First multi-room school built in North Branford for grades 1-8, used from 1920-1960.</p> <p>Used as town's administration building with offices for town clerk, assessor, tax collector, planning and zoning director, human relations director, building inspector, town manager and housing all town records. 1960-1979.</p> <p>Town's first police station was in basement, 1971-1975.</p> <p>Used as communications center, 1975-1978.</p> <p>Zion Episcopal Church was located in front and slightly to the east until it was moved to its present site on Notch Hill Rd. in 1957.</p> <p>Original owner of the property was John Harrison who came to "North Farms" in 1707.</p>	William E. Becroft of Wallingford	BUILDER O. C. Kelsey (bid \$11,945)

NAME Janet S. Grogan	11/1/79																		
ORGANIZATION Totoket Historical Society, Inc.																			
ADDRESS P. O. Box 117, Northford, Ct. 06472																			
20 SUBSEQUENT FIELD EVALUATIONS																			
<table border="1" style="width:100%; border-collapse: collapse;"> <tr> <td colspan="4">21 THREATS TO BUILDING OR SITE</td> </tr> <tr> <td><input type="checkbox"/> None known</td> <td><input type="checkbox"/> Highways</td> <td><input type="checkbox"/> Vandalism</td> <td><input type="checkbox"/> Developers</td> </tr> <tr> <td><input type="checkbox"/> Renewal</td> <td><input type="checkbox"/> Private</td> <td><input type="checkbox"/> Deterioration</td> <td><input type="checkbox"/> Zoning</td> </tr> <tr> <td colspan="2"></td> <td colspan="2"> <input checked="" type="checkbox"/> Other Demotion-If no viable plan is presented to the <input type="checkbox"/> Explanation Town Council by 6/30 </td> </tr> </table>				21 THREATS TO BUILDING OR SITE				<input type="checkbox"/> None known	<input type="checkbox"/> Highways	<input type="checkbox"/> Vandalism	<input type="checkbox"/> Developers	<input type="checkbox"/> Renewal	<input type="checkbox"/> Private	<input type="checkbox"/> Deterioration	<input type="checkbox"/> Zoning			<input checked="" type="checkbox"/> Other Demotion-If no viable plan is presented to the <input type="checkbox"/> Explanation Town Council by 6/30

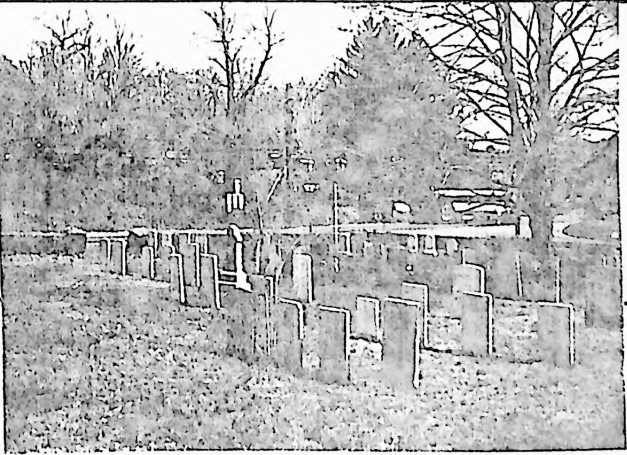
DESCRIPTION (Continued)	17 OTHER NOTABLE FEATURES OF BUILDING OR SITE (interior and or exterior)	
	<ol style="list-style-type: none"> 1. Cemented stone wall on North and East. 2. 66 Stones - sandstone, marble and granite, all facing west - the direction where the church originally stood. 3. 2 large trees. 	
SIGNIFICANCE	18 ARCHITECT	BUILDER
	19 HISTORICAL OR ARCHITECTURAL IMPORTANCE <ol style="list-style-type: none"> 1. Purchased in 1818 by subscription for a burying ground for the Episcopal Parish, May 11, 1818. 2. Oldest grave is dated 1796, is of Henrietta Rose, daughter of Jonathan & Hannah, age 2 yrs., 8 mos. Another daughter Roberta died Jan. 6, 1806, age 14, and a son, Robert died at sea, July 1815, age 27. It is possible that these graves were moved here after burying ground was purchased. All other graves date from 1822 on. 	
SOURCES	Assessor's Records - 20 - 61 Cemetery records, Conn. State Library

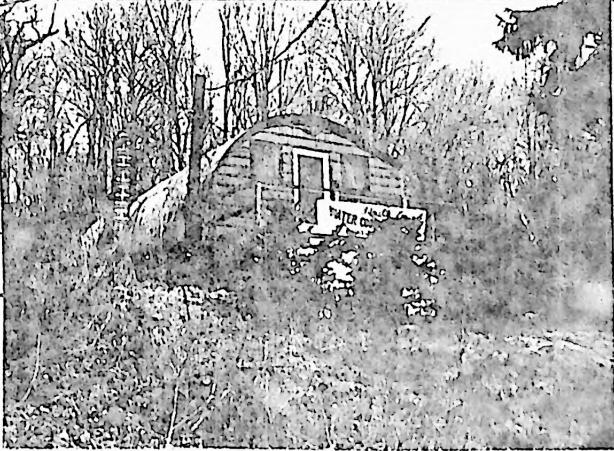
DESCRIPTION (Continued)	17 OTHER NOTABLE FEATURES OF BUILDING OR SITE (interior and/or exterior) 1. Shingled ends. Small open porch on front. Casement windows on sides - 1 on left, 4 on right.	
	18 ARCHITECT	BUILDER
SIGNIFICANCE	19 HISTORICAL OR ARCHITECTURAL IMPORTANCE 1. Quonset hut brought from Yale Campus.* 2. Used as residence 1946 to 1970.	
	SOURCES Assessor's Records *Robert Newton - assessor N. B. Land Records	
COMPILED BY	PHOTOGRAPHER Ruth Arnold 6/79	
	VIEW Front	NEGATIVE ON FILM yes
	NAME Janet S. Grogan 3/80	
	ORGANIZATION Totoket Historical Society, Inc.	
	ADDRESS P. O. Box 117, Northford, CT 06472	
20 SUBSEQUENT FIELD EVALUATIONS		
<div style="display: flex; align-items: center;">

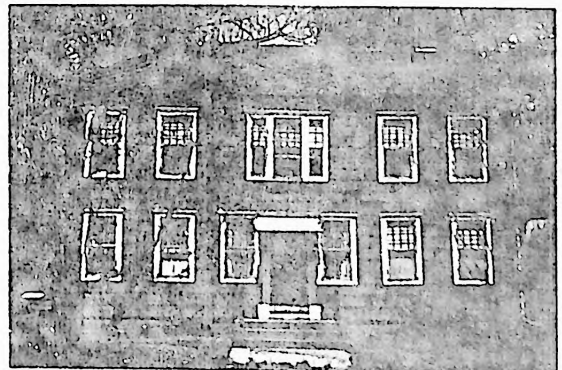
16. INTERRELATIONSHIP OF BUILDING AND SURROUNDINGS	
	House sited on north side of Rt. 80 at junction of Rts. 139 & 22, & Church St. It is close to road with hill rising right behind it. To east is Victorian Carriage house used as antique shop. To west is a Quonset hut- once used as a residence, now empty & deteriorated.

DESCRIPTION (Continued)	17 OTHER NOTABLE FEATURES OF BUILDING OR SITE (interior and/or exterior) Architecture: Five-bay facade with square-headed Palladian window (side sashed two panes wide). Central door has full-size sash on either side and leads into very wide central hall. At one time there was a small portico with Doric columns (WPA); now an aluminum hood. Sash are 12/1; two 6/6 windows in each gable. Two interior chimneys with unusual "battered" 7 top courses. Plain board wainscot in central hall. Stairs are enclosed at rear corner. Seven rooms on first floor; six on second.	
	18 ARCHITECT	BUILDER
SIGNIFICANCE	19 HISTORICAL OR ARCHITECTURAL IMPORTANCE Probably built by Nathan Harrison for his son, General Philo Harrison (1793-1829). House was built as a tavern. It eventually came into the hands of Charles Albert Harrison in 1869. He was a lawyer in Wallingford and used it as a summer home until 1928. House was opened to the public on Oct. 15, 1902 as part of the 175th Celebration Festivities of the North Branford Congregational Church. "C. A. Harrison, Esq. kindly opened his summer home, the lower rooms of which were filled with relics of the olden times." (1) There were extensive gardens surrounding house in the early part of this century. (2)

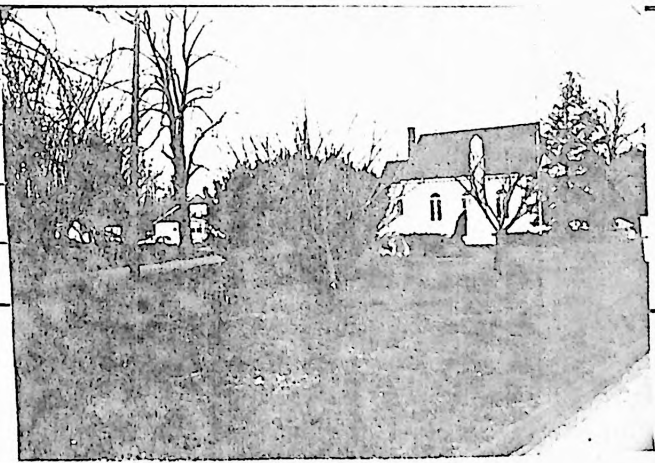
DESCRIPTION (Continued)	17 OTHER NOTABLE FEATURES OF BUILDING OR SITE (interior and or exterior)		<ol style="list-style-type: none"> 1. Civil War Monument-granite obelisk on square base from quarry of Burdick & Co., Westerly, R. I. 2. World War I monument-Bronze plaque-mounted on rough hewn granite boulder. Erected by N. B. Civic Association for celebration of Conn. Tercentary 1935 to replace painted Honor Roll. 3. World War II monument - Bronze plaque mounted on smooth sided granite stone from Stony Creek quarry erected 1955 by VFW and Memorial Day Committee. 4. The Green was landscaped by church members in 1966, following planting plan designed by Rudy Favretti.
	18 ARCHITECT	BUILDER	
SIGNIFICANCE	19 HISTORICAL OR ARCHITECTURAL IMPORTANCE		
	<ol style="list-style-type: none"> 1. Civil War Monument reputed to be first one erected in country, dedicated April 16, 1866. Lists 7 names-with rank, unit when & where died. 2. World War I - lists 17 names of men who died. 3. World War II - lists 6 names. 4. Every other year - grandstand for Memorial Day Parade is erected here. 5. Sign post - used for posting all legal notices. 6. Flagpole given by Veterans of Foreign Wars to replace earlier hickory pole-reputed to be spot where the Rev. Samuel Eells gathered his company of volunteers in 1777.

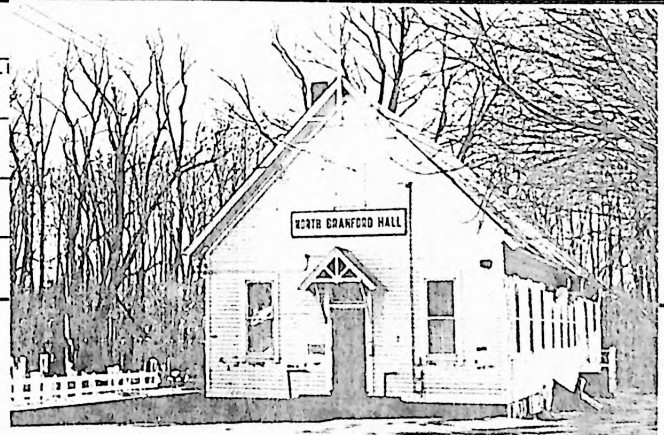
SIGNIFICANCE	19 HISTORICAL OR ARCHITECTURAL IMPORTANCE
	1. Original School House was drawn to present location in 1867 from Green from about where Soldiers (Civil War) Manument stands.
	2. County Maps 1852 & 1856 show school house across Rt. 80. Present building replaced old school about 1870. Used as school until 1920 when it became the Town Hall.
	3. The North Branford Civic Association (formed April 6, 1921) used the Town Hall for meetings and social affairs and raised money for improvements and upkeep. In 1925, a building was purchased in North Madison for \$50.00. The lumber was used to build the addition to rear with a \$1,000 bond borrowed by Town, but paid off by monies raised by Civic Associations. The 1929 kitchen addition was also paid for by Civic Association monies. (Cont.)

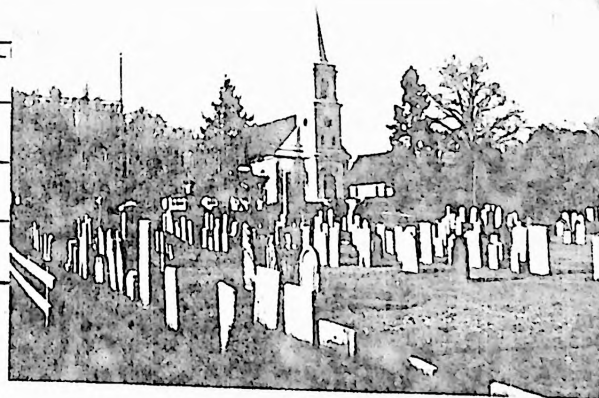
DESCRIPTION (Continued)	17 OTHER NOTABLE FEATURES OF BUILDING OR SITE (interior and or exterior) 1. Iron fence along highway-wooden rail fence on west-wire fence on east and south. 2. Most stones are in various states of deterioration-especially older ones. Some are broken, split or missing. 3. Most stones face west, some east, a few north.	
	18 ARCHITECT 19 HISTORICAL OR ARCHITECTURAL IMPORTANCE	BUILDER
SIGNIFICANCE	1. The first burying ground was located to the east of Congregational Church. In 1804 the Society voted to make some arrangement with Jairus Harrison for exchanging or procuring additional burying ground. 2. When Chapel was built in 1887, the grave stones were moved from old burying ground to their present location across Foxon Rd. Oldest stone was Isaac Bartholomew, d. 1727 age 63. 3. June 11, 1804 voted to rent the burying yards to the Pasturing of Sheep only. 4. Gravestones of the first three ministers located here. The Rev. Jonathan Merrick-minister from 1727-1769, d. 1782. The Rev. Samuel Eillis-minister 1769-1808, d. 1808. The Rev. Charles Atwater-minister 1808-1825, d. 1825.

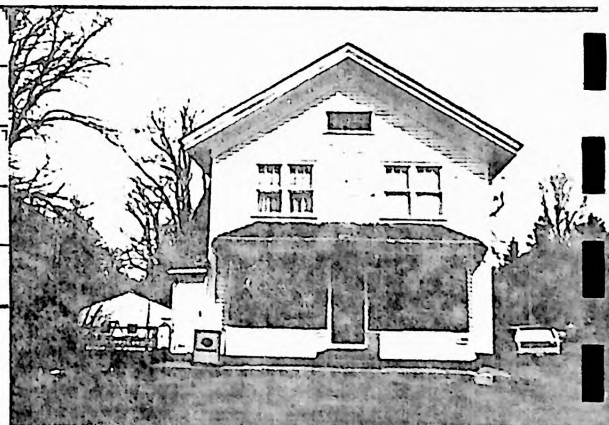
DESCRIPTION (Continued)	17 OTHER NOTABLE FEATURES OF BUILDING OR SITE (interior and or exterior)	
	1) Two additions to original store: first - foundation fieldstone to grade level and stuccoed brick above grade; second - foundation concrete block. 2) Substantial roof overhangs on all sides, no cornice returns. 3) Second story windows 6/1. Paired window configuration likely not original. 4) Two windows in attic, 12 pane, horizontal, pediment windows. 5) Storefront relatively new.	
SIGNIFICANCE	18 ARCHITECT	BUILDER
	19 HISTORICAL OR ARCHITECTURAL IMPORTANCE 1) Store was built by Russell Clark in 1851 who bought 1½ acres near Meeting House from William A. Reynolds. He operated it until 1871. It passed through several ownerships but was rented in 1887 by Ralph Beers who finally purchased it in 1909. It served as a store, post office and meeting place. There was a large room upstairs used for meetings, drama productions and dances. In 1920 R. Farle Beers, Ralph's son, was elected Town Clerk and the building served as Town Clerk's office from 1920-1928. Beers sold store to Anna and Richard Scholtz who operated store until 1970. It was then sold to present owner, who rents out store. Presently store is empty but apartment is rented.

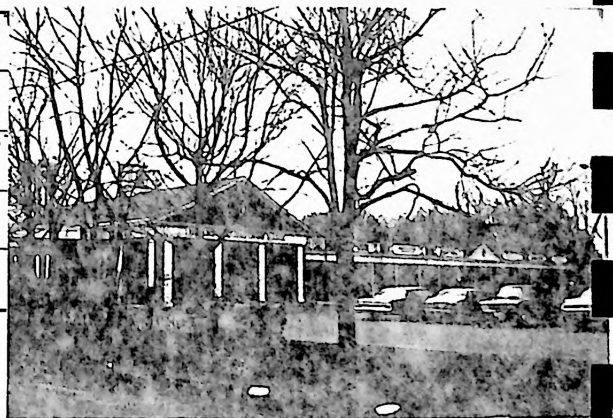
DESCRIPTION (Continued)	17 OTHER NOTABLE FEATURES OF BUILDING OR SITE (interior and or exterior)	
	Designed to fit with historic surroundings.	
SIGNIFICANCE	18 ARCHITECT	BUILDER
	Shilling & Goldbecker	Branford Building and Tile
SOURCES	19 HISTORICAL OR ARCHITECTURAL IMPORTANCE	
	<p>Helps define center of North Branford.</p> <p>Part of potential historic district.</p> <p>Original site was site of #</p>	
PHOTO	David Wight, architect.	
	Beers Atlas 1868.	
COMPILED BY	PHOTOGRAPHER	DATE
	Ruth Arnold 4/1979	
	VIEW	NEGATIVE ON FILE
	3/4 front - Northeast	Yes
	NAME	DATE
	Janet S. Grogan 6/30/79	
	ORGANIZATION	
	Totoket Historical Society, Inc.	
	ADDRESS	
	P.O. Box 117, Northford, CT 06472	
20 SUBSEQUENT FIELD EVALUATIONS		
21 THREATS TO BUILDING OR SITE		
<input checked="" type="checkbox"/> None known <input type="checkbox"/> Highways <input type="checkbox"/> Vandalism <input type="checkbox"/> Developers <input type="checkbox"/> Other _____

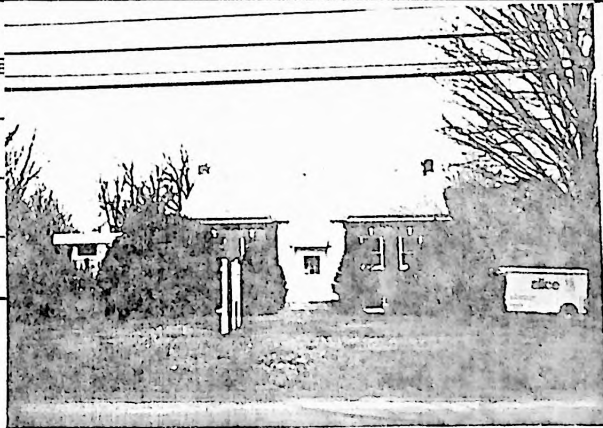
DESCRIPTION (Continued)	17 OTHER NOTABLE FEATURES OF BUILDING OR SITE (interior and or exterior)		1. Original building 25' x40' built with Conn. brick. Gabled wood portico on south facade with recessed doorway. 2. Quoined brick at front corners. 3. Keystones over south facade windows. 4. Decorative cupola. 5. Original building had 16' x 26' lecture room, furnace room & storage space in basement, reading shelf rooms on 1st floor, and office space to town officials & Judge of Probate on 2nd floor. 6. Addition added to rear in 1967 with glass faced entrance on north side with interior split level stairway. Top level(1st story) is adult section with main desk. Basement level is children's section. 7. Lecture room used as meeting room & story room. Reading rooms are reference room & head librarian's office. Second story (Cont.)
	18 ARCHITECT	BUILDER	
SIGNIFICANCE	19 HISTORICAL OR ARCHITECTURAL IMPORTANCE See Continuation Sheet

1. Library was built by funds provided in will of James Atwater as a memorial to his father, the Rev. Charles Atwater, minister of the Congregational Church (1808-1825), under the direction of James nephew, Charles B. Atwater. 2. Site deeded to the town July 15, 1765 by Nathan Palmer for "a place of Parade and other Publick Exercises and uses and purposes.", also called the Common, the Green, or Drilling Ground. It was originally approximately 10 rods square and considered the center of village. 3. Library is used also as meeting place for small groups, and displays of historic & cultural items.		
SOURCES	Talmadge, John A., Jr. - A History of North Branford's Two Libraries-The First Thirty Years Assessors - 26-33 Library Board of Directors Minutes Branford Land Records 8-319		
COMPILED BY	PHOTOGRAPHER

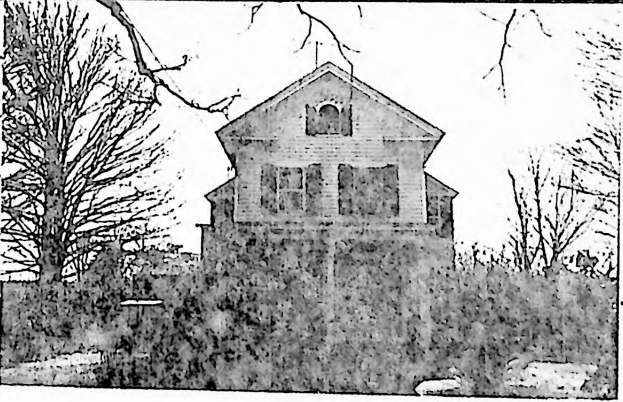
DESCRIPTION (Continued)	17 OTHER NOTABLE FEATURES OF BUILDING OR SITE (interior and/or exterior)		1. Workshop building was once an avairy - moved from Seven Brooks farm on Branford Rd. and used as a roadside stand for home baked goods by owner's mother. 2. One of the sheds was a bunk house from the City Mission Summer Camp which was located on land a little way east of house. 3. Arched window in gable end and first floor window matched by arched door on opposite side. (Front had French doors opening to porch-replaced by windows.) 4. Second floor front windows have shallow arched lintel trim. All windows 2/2. (Cont.)
	18 ARCHITECT	BUILDER	Built by/for Thomas Plant
	19 HISTORICAL OR ARCHITECTURAL IMPORTANCE		
	SOURCES		
COMPILED BY	PHOTOGRAPHER		Ruth Arnold
	VIEW	NEGATIVE ON FILM	front 2/1980 yes
	NAME		Janet S. Grega
	ORGANIZATION		Totoket Historical Society, Inc.
	ADDRESS		P. O. Box 117, Northford, CT 06472

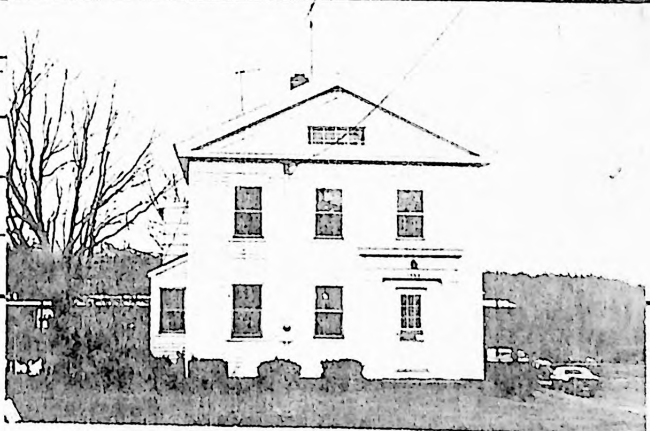
DESCRIPTION (Continued)	17 OTHER NOTABLE FEATURES OF BUILDING OR SITE (interior and or exterior)		Doorway has simple strong entablature-plain flat pilasters- might have had side lights but now wood panels. Sandstone step. Gable end to road. 3 bay facade. Side hall plan. Closed pediment with multi paned horizontal window. Windows-right side & rear addition 6/1. Left side 6/6. Small wing on left part of original house-large two story addition on rear with cement block basement wall fully exposed. 2 octagon windows, 1st & 2nd story level, on rt. side installed 1980. Interior completely remodeled-no fireplaces.	
	18 ARCHITECT	BUILDER	By/for Abram Wheaton	
SIGNIFICANCE	19 HISTORICAL OR ARCHITECTURAL IMPORTANCE

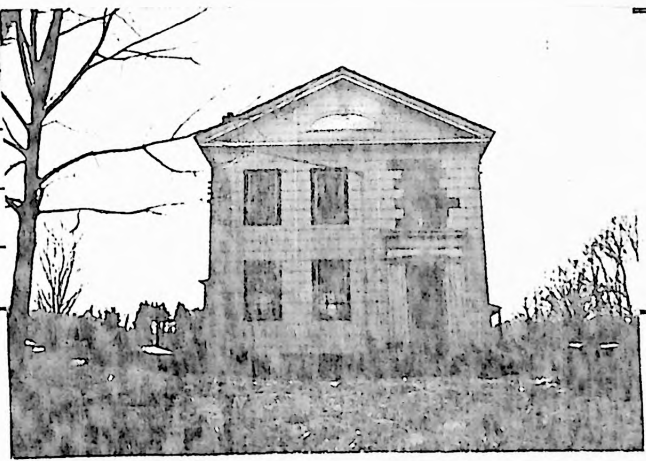
DESCRIPTION (Continued)	17 OTHER NOTABLE FEATURES OF BUILDING OR SITE (interior and or exterior)																
	<ol style="list-style-type: none"> 1. Greek revival entry surround with simple fretwork at tops and bottoms of pilasters. 2. Infill panel set into original fanlight in enclosed pediment. Trim with center key remains. 3. Windows 6/6, second floor window above door removed. 																
SIGNIFICANCE	18 ARCHITECT	BUILDER By/for Alonzo Appell															
	19 HISTORICAL OR ARCHITECTURAL IMPORTANCE Alonzo Appell married Lois, daughter of Capt. Augustus and Lydia Rose Russell. Alonzo Appell (1805-1870)																
SOURCES	Assessor's records 33-33 County Map 1852-1856 Beers Atlas May 1869 Martha Russell's "Notes" Cemetery Records																
PHOTO COMPILED BY	PHOTOGRAPHER Ruth Arnold 4/79																
	VIEW Front	NEGATIVE ON FILM yes															
	NAME Janet S. Gegan 2/80																
	ORGANIZATION Totoket Historical Society, Inc. ADDRESS P. O. Box 117, Northford, CT 06472																
20 SUBSEQUENT FIELD EVALUATIONS																	
<div style="display: flex; align-items: center;">

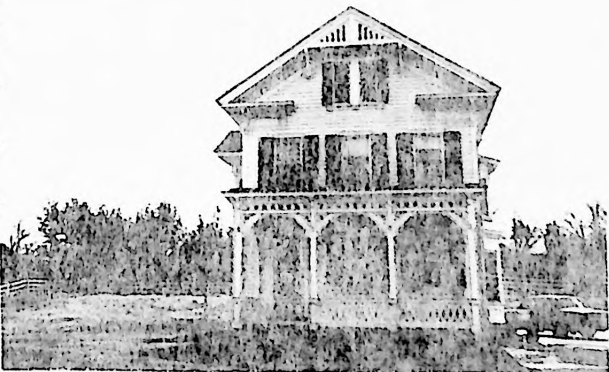
DESCRIPTION (Continued)	17 OTHER NOTABLE FEATURES OF BUILDING OR SITE (interior and/or exterior)		<p>House has 3 gables, front, back and east wing. Two story, bracketed bay window at west. 3 bay front facade, wide cornices with deep returns. Heavy dentil course around main and raked cornices. Large, curved brackets under cornice at corners on each facade. Similar brackets under raked cornice support each end of gable apron, which is composed of a king post, tie beam and vertically slotted infill panels. 3 bay front porch supported by square chamfered columns on plinths. Diagonal braces on column heads infilled with circular openings. Above porch tie beam is a frieze with a series of circular cuts. Brackets over each column supports porch cornice. Cut out pattern in porch railing resembles an expanded folded paper cut out. 2/2 windows with molded trim. Pair of flat headed 1/1 windows with small brackets under sills in front gable. Arched, stained glass window on east side of house-clear portion in center. (Cont.)</p>

18 ARCHITECT	BUILDER	By/for Edson S. Beardsley
SIGNIFICANCE	19 HISTORICAL OR ARCHITECTURAL IMPORTANCE		
	<p>Originally located near center of North Branford where the Branford Savings Bank Plaza is now located. Moved April 30, 1970, by John Barrett, who owned the property it is now on. The Stevens family lived there 1901-1970.</p>		
SOURCES	<p>Assessors records 41-13 N. B. Land Records 9-287 Letter from Alta Stevens Ross Ramsay, owner 1953-1969 to THS 1976</p>		
PHOTO	PHOTOGRAPHER		6/79
	Ruth Arnold		
COMPILED BY	VIEW	NEGATIVE ON FILM	
	Front	yes	
	NAME		
	Janet S. Gegan		
ORGANIZATION

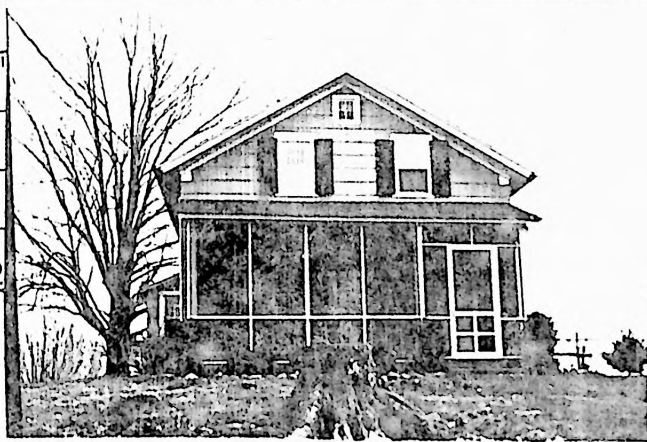
7. STYLE OF BUILDING		DATE OF CONSTRUCTION	
Greek Revival		C. 1850	
8. MATERIAL(S) (Indicate use or location when appropriate)			
<input type="checkbox"/> Clapboard	<input checked="" type="checkbox"/> Asbestos Siding	2 <input checked="" type="checkbox"/> Brick	<input type="checkbox"/> Other (Specify)
<input type="checkbox"/> Wood Shingle	<input type="checkbox"/> Asphalt Siding	<input checked="" type="checkbox"/> Fieldstone	chimneys; one central; modern on ell
<input type="checkbox"/> Board & Batten	<input type="checkbox"/> Stucco	<input type="checkbox"/> Cobblestone	foundation-below ground level
<input type="checkbox"/> Aluminum Siding	<input checked="" type="checkbox"/> Concrete	<input checked="" type="checkbox"/> Cut stone	Foundation
poured-back addition

11. NUMBER OF STORIES		APPROXIMATE DIMENSIONS	
1 1/2		30' x 54'	
12. CONDITION (Structural)		(Exterior)	
<input type="checkbox"/> Excellent	<input checked="" type="checkbox"/> Good	<input type="checkbox"/> Fair	<input type="checkbox"/> Deteriorated
<input type="checkbox"/> Excellent	<input checked="" type="checkbox"/> Good	<input type="checkbox"/> Fair	<input type="checkbox"/> Deteriorated
