The Historical and Architectural
Survey of North Branford

Part B

Prepared by
Totoket Historical Society, Inc.
under the direction of
Frank J. Pannenberg

May 1980

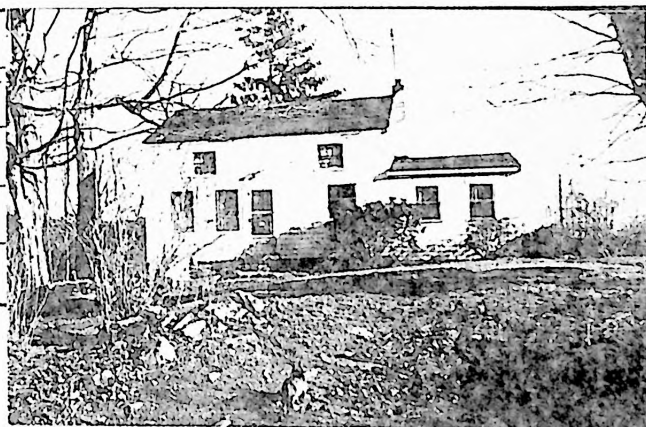
11. NUMBER OF STORIES	APPROXIMATE DIMENSIONS
1 1/2	20' x 37'
12. CONDITION (Structural)	(Exterior)
<input type="checkbox"/> Excellent <input type="checkbox"/> Good <input checked="" type="checkbox"/> Fair <input type="checkbox"/> Deteriorated	<input type="checkbox"/> Excellent <input type="checkbox"/> Good <input checked="" type="checkbox"/> Fair <input type="checkbox"/> Deteriorated

DESCRIPTION (Continued)	17 OTHER NOTABLE FEATURES OF BUILDING OR SITE (interior and/or exterior)	
	<p>Wing on south has poured concrete foundation-recent addition. House is sited gable end to road, front faces west. First story windows are 8/1 + 6/6 + 6/1 + 1/1; second story windows are 3/3; two windows in each gable. Low pitch to roof.</p>	
SIGNIFICANCE	18 ARCHITECT	BUILDER
		By/for Harry Johnson
SOURCES	19 HISTORICAL OR ARCHITECTURAL IMPORTANCE	
	<p>This is on the site of an early house built by Adonijah Rose who married 1785. Present house built by/for Harry Johnson (1805-1888). His wife Harriet or Hannah (1819-1911) descended from the Harrisons and Russells.</p>	
PHOTO	Assessor's records 17-19 County Maps 1852-1856 Beers Atlas 1868 Martha Russell's <u>Notes</u> Talk with Florence Juniver, whose father bought house from the Johnsons	
	PHOTOGRAPHER Ruth Arnold VIEW Front (west)	11/79 NEGATIVE ON FILM yes

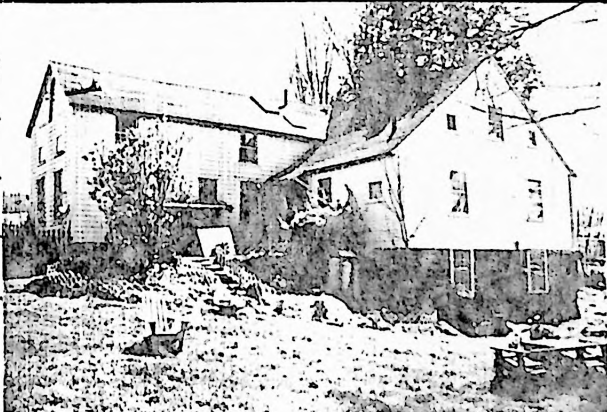
11. NUMBER OF STORIES		APPROXIMATE DIMENSIONS		
1 1/2 & 2		35' x 52' (main 35' x 28') (ell 16' x 24')		
12. CONDITION (Structural) (Exterior)				
<input type="checkbox"/> Excellent <input checked="" type="checkbox"/> Good <input type="checkbox"/> Fair <input type="checkbox"/> Deteriorated <input type="checkbox"/> Excellent <input checked="" type="checkbox"/> Good <input type="checkbox"/> Fair <input type="checkbox"/> Deteriorated

DESCRIPTION (Continued)	17 OTHER NOTABLE FEATURES OF BUILDING OR SITE (interior and or exterior) Main house with center chimney (3 cut stone fireplaces). Large fireplace in earth-floored cellar. Wide board floors. Ell later, probably enlarged from a woodshed. Unbalanced sash, 8/12, in main house. Two small and one large window in gables. Apparently there never was a front door.	
	18 ARCHITECT	BUILDER
SIGNIFICANCE	19 HISTORICAL OR ARCHITECTURAL IMPORTANCE According to a previous owner (Mrs. Charles Brennan) who purchased it in 1948, there were tales that during Prohibition the house was a speakeasy and whorehouse. At that time it was very isolated, the only house on a road that went over Totoket Mountain near Lane's Pond. The only survivor of a number of houses built by the Fowler family in the "White Hollow" area which until about 1890 was part of Guilford.	
	SOURCES County Map 1852-1856 Guilford Beers Atlas-1868 Former owner-Mrs. Charles Brennan

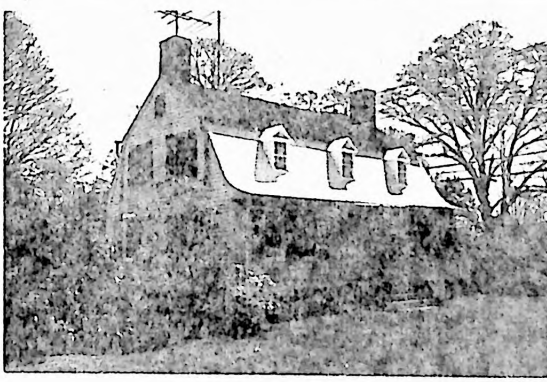
7. STYLE OF BUILDING		DATE OF CONSTRUCTION	
Colonial		1786	
8 MATERIAL(S) (Indicate use or location when appropriate)			
<input checked="" type="checkbox"/> Clapboard <input type="checkbox"/> Asbestos Siding <input checked="" type="checkbox"/> Brick <input type="checkbox"/> Other (Specify) _____ 2 chimneys <input type="checkbox"/> Wood Shingle <input type="checkbox"/> Asphalt Siding <input checked="" type="checkbox"/> Fieldstone foundation <input type="checkbox"/> Board & Batten <input type="checkbox"/> Stucco <input type="checkbox"/> Cobblestone <input type="checkbox"/> Aluminum Siding <input type="checkbox"/> Concrete Type: _____ <input checked="" type="checkbox"/> Cut stone Type: dressed sandstone-front foundation			
9 STRUCTURAL SYSTEM			
<input checked="" type="checkbox"/> Wood frame <input checked="" type="checkbox"/> Post and beam <input type="checkbox"/> balloon <input type="checkbox"/> Load bearing masonry <input type="checkbox"/> Structural iron or steel <input type="checkbox"/> Other (Specify) _____

DESCRIPTION (Continued)	17 OTHER NOTABLE FEATURES OF BUILDING OR SITE (interior and/or exterior) Architecture: Exterior: This gambrel roof house is unique in style in N. B. Five-bay facade with 3 small dormers on second floor. The front slope of the roof curves out, projecting about three feet, rather in the Dutch style. However, in the 19th century a porch was added across the front so there may have been alterations. Shutters are modern. The front door has a five-pane transom light. Fluted pilasters are mounted on flat boards scored horizontally. The double leaf door has heavy raised molding and is very unusual in being hinged on one side and in the middle. Two wings at the rear are early additions. The south wing is Greek Revival in style with one-by-three pane horizontal windows on the second floor.	
	(Cont.)	
SIGNIFICANCE	18 ARCHITECT	BUILDER
	19 HISTORICAL OR ARCHITECTURAL IMPORTANCE House was probably built by/for Hezekiah Reynolds and his wife, Martha Davenport Reynolds about 1786. Martha was the sister of Thomas Goodsell Wolcott. Hezekiah was a jeweler. A store was associated with house according to early deeds. In 1793, Hezekiah Reynolds sold it to Justus Rose & , in exchange, bought the farm Justus had purchased from Stephan Linsley. Justus Rose wanted the house for his daughter, Abigail (1772-1855), who married Beverly Munro. Beverly Munro served as 2nd Society Clerk 1797-1808 when he died suddenly. Abigail married for the second time, Hezekiah Clark. The house passed out of her hands in 1833 but was repurchased by her son Russell Clark (1811-1879) in 1851. Russell Clark who married Cloe Palmer (1813-1885) owned the store across the common. In 1873, Dr. Edward A. Wood bought the house & had his office there. It was purchased by Ralph Beers in 1889 who also purchased (Cont.

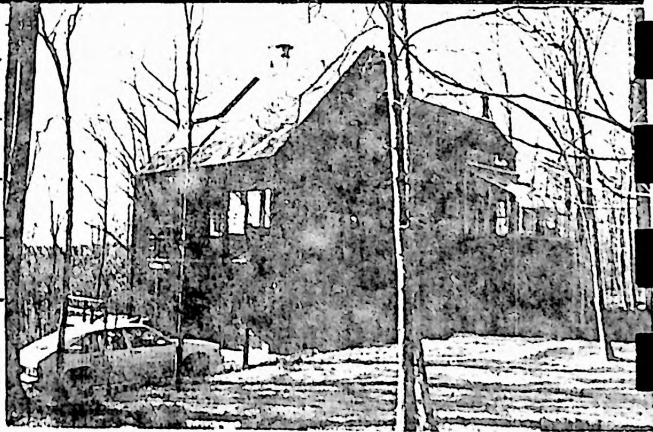
11. NUMBER OF STORIES		APPROXIMATE DIMENSIONS	
3		35' x 35' Approx.	
12. CONDITION (Structural)		(Exterior)	
<input checked="" type="checkbox"/> Excellent <input type="checkbox"/> Good <input type="checkbox"/> Fair <input type="checkbox"/> Deteriorated		<input checked="" type="checkbox"/> Excellent <input type="checkbox"/> Good <input type="checkbox"/> Fair <input type="checkbox"/> Deteriorated

DESCRIPTION (Continued)	17 OTHER NOTABLE FEATURES OF BUILDING OR SITE (interior and/or exterior)	
	1) Solar panels on roof for domestic hot water. 2) Hot air heating by wood-burning furnace - owner is considering switching to solar panels for heating. 3) Low voltage switching for lighting. 4) Walled in sun deck on roof, 25' X 35' wood deck at first floor level at rear. 5) Built-in green house in front (used as integral part of architecture). 6) Circular stair tower at rear, semi-circular shaft exposed at rear. 7) Cast in place bathtub in master bathroom.	
	18 ARCHITECT	BUILDER
	Donald Watson	Owners were their own general Contractors - Frank McGuire did framing.
	19 HISTORICAL OR ARCHITECTURAL IMPORTANCE	
	The architect Donald Watson, is well known for his work in solar buildings. His buildings have been published in many periodicals and books. He has authored one book and several articles on the subject of solar design in architecture. Photo of house on page 184.

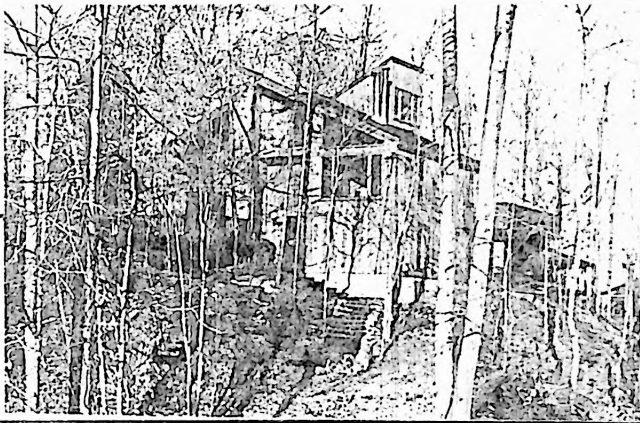
11. NUMBER OF STORIES APPROXIMATE DIMENSIONS			
6 levels - equiv. 3 stories		32' X 32' approx.	
12. CONDITION (Structural)			
<input checked="" type="checkbox"/> Excellent	<input type="checkbox"/> Good	<input type="checkbox"/> Fair	<input type="checkbox"/> Deteriorated
(Exterior)			
<input checked="" type="checkbox"/> Excellent	<input type="checkbox"/> Good	<input type="checkbox"/> Fair	<input type="checkbox"/> Deteriorated

DESCRIPTION (Continued)	17 OTHER NOTABLE FEATURES OF BUILDING OR SITE (interior and/or exterior)		
	1) Multi-level house - 6 levels total. 2) Central fireplace of marble. 3) All wood ceilings - fir. 4) Loft at top of house reached by spiral staircase. 5) Open stairs throughout. Interior balcony from second floor bedroom open to living room below. 6) Two decks and two balconies on exterior.		
SIGNIFICANCE	18 ARCHITECT John Giaimo (owner) did design.		BUILDER John Giaimo (owner) acted as owner. general contractor - Joe Lanno did framing.
	19 HISTORICAL OR ARCHITECTURAL IMPORTANCE		
SOURCES	Owner - John Giaimo

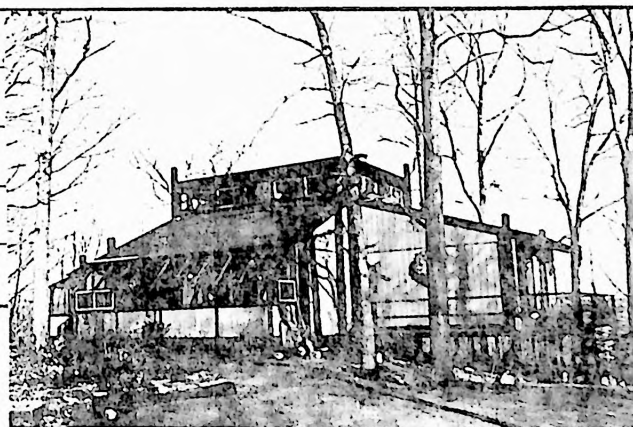
11. NUMBER OF STORIES		APPROXIMATE DIMENSIONS		
2		50' X 60'		
12. CONDITION (Structural)				
<input checked="" type="checkbox"/> Excellent <input type="checkbox"/> Good <input type="checkbox"/> Fair <input type="checkbox"/> Deteriorated <input checked="" type="checkbox"/> Excellent (Exterior) <input type="checkbox"/> Good <input type="checkbox"/> Fair <input type="checkbox"/> Deteriorated

- 1) Raised, exterior deck.
- 2) "Modular" building plan as described by builder-owner, Dennis Burk. Center module on concrete foundation with side wings or "modules" floating free of foundations on vertical timber poles on outer corners.
- 3) Interior spaces interconnect with second story solarium at central location.
