The Historical and Architectural
Survey of North Branford

Prepared by
Totoket Historical Society, Inc.
under the direction of
Frank J. Pannenburg

May 1980

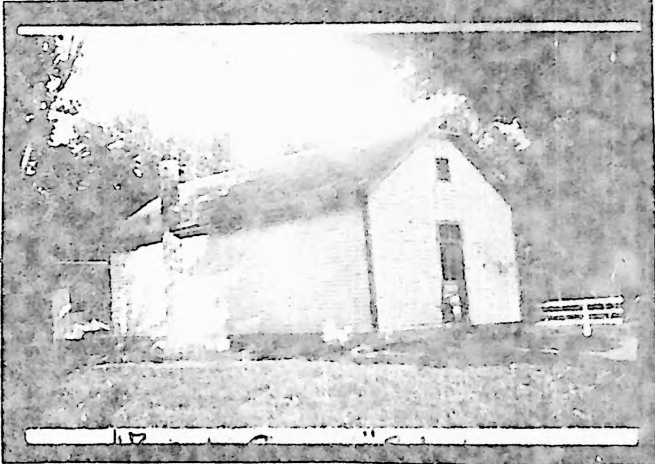
DESCRIPTION (Continued)	17 OTHER NOTABLE FEATURES OF BUILDING OR SITE (interior and or exterior)	
	<p>Original building was a simple clapboarded, gabled box with a small gable decoration comprising of a king post and tie beam and a centered door and louvered attic vent port on the front facade. The south and west elevations were windowless as was probably the north. Field-stone foundation. On converting this to a residence many windows were added along with an addition with a cinder block foundation.</p>	
SIGNIFICANCE	18 ARCHITECT	BUILDER
	19 HISTORICAL OR ARCHITECTURAL IMPORTANCE	
	<p>Used as school until 1918. Was dance hall for short time. No well when school was here. Had to bring water from other houses for drinking. There has been a school located at this corner since sometime in the mid 1700's. Present building probably replaced earlier one, but there is no indication in town records when it was built. 1875 date is a guesstimate (see old photo).</p>

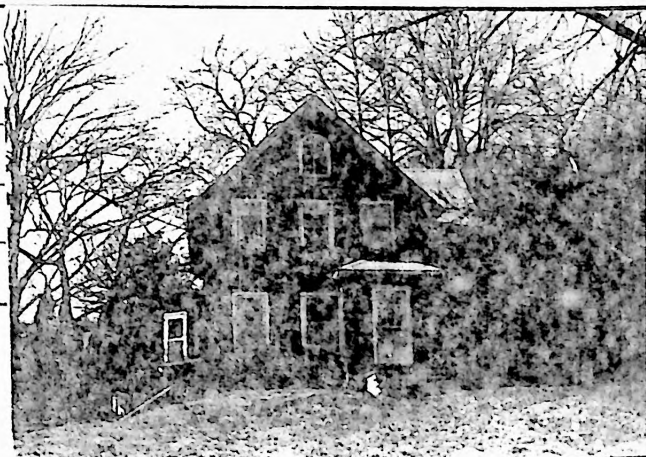
11. NUMBER OF STORIES		APPROXIMATE DIMENSIONS	
2 + attic		34' x 38' (main house 20' x 30')	
12. CONDITION (Structural)			
<input type="checkbox"/> Excellent	<input checked="" type="checkbox"/> Good	<input type="checkbox"/> Fair	<input type="checkbox"/> Deteriorated
		(Exterior)	
<input type="checkbox"/> Excellent	<input checked="" type="checkbox"/> Good	<input type="checkbox"/> Fair	<input type="checkbox"/> Deteriorated

1. Unusual bay window at first story level extends down through basement with brick foundation. It has 5 sides. Three wider segments have a window in each at first floor level and a smaller window at basement level. Two other segments nearest wall have closed panel. Ornamental brackets under eave of bay.
2. Plain, unornamented bargeboards on gables with ends cut horizontally.
3. Original 2/2 windows with single 2/2 arched window in gable.

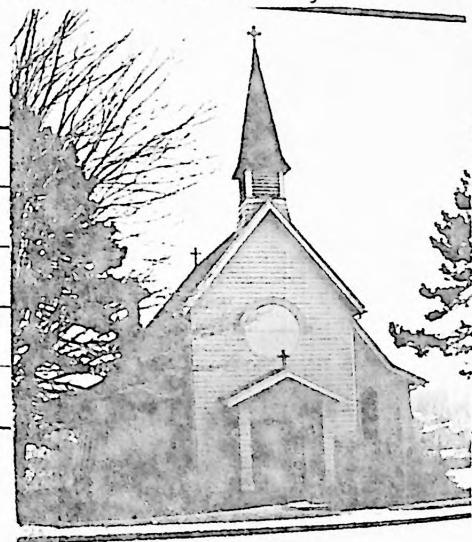
7. STYLE OF BUILDING _____		DATE OF CONSTRUCTION _____	
Gothic _____		1925 _____	
8. MATERIAL(S) (Indicate use or location when appropriate)			
<input checked="" type="checkbox"/> Clapboard <input type="checkbox"/> Asbestos Siding <input checked="" type="checkbox"/> Brick <input type="checkbox"/> Other (Specify) _____			
foundation & one flue chimney			
<input type="checkbox"/> Wood Shingle <input type="checkbox"/> Asphalt Siding <input type="checkbox"/> Fieldstone			
<input type="checkbox"/> Board & Batten <input type="checkbox"/> Stucco <input type="checkbox"/> Cobblestone			
<input type="checkbox"/> Aluminum Siding <input type="checkbox"/> Concrete Type: _____ <input type="checkbox"/> Cut stone Type: _____

11. NUMBER OF STORIES _____		APPROXIMATE DIMENSIONS _____	
1 1/2 _____		37' x 53' _____	
12. CONDITION (Structural) _____ (Exterior) _____			
<input type="checkbox"/> Excellent <input checked="" type="checkbox"/> Good <input type="checkbox"/> Fair <input type="checkbox"/> Deteriorated <input type="checkbox"/> Excellent <input checked="" type="checkbox"/> Good <input type="checkbox"/> Fair <input type="checkbox"/> Deteriorated

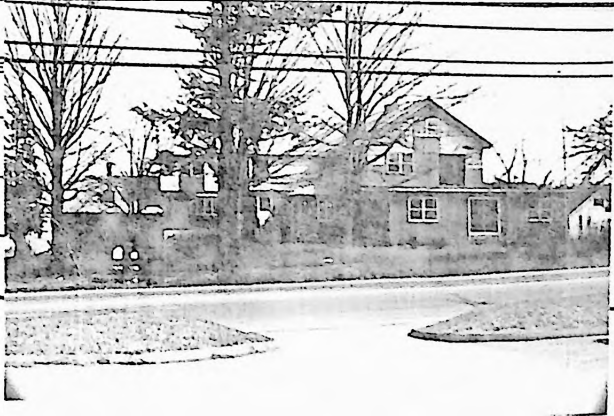
DESCRIPTION (Continued)	17 OTHER NOTABLE FEATURES OF BUILDING OR SITE (interior and or exterior)	
	Extensively remodeled and many additions - between 1974-1979, to convert the former nursing home and former barns in rear to make a complex of 14 apartments. Only the foundation and structure of the original house remains.	
SIGNIFICANCE	18 ARCHITECTURE	BUILDER By/for Charles Todd
	19 HISTORICAL OR ARCHITECTURAL IMPORTANCE Former 17 bed Convalescent Home - until 1966. The property originally belonged to John Harrison, who settled here around 1707. Charles Todd acquired the property c. 1844 and built the present house.	
SOURCES	Assessor's Records County Maps 1852-1856 Beers Atlas Map - 1868 Martha Russell's Notes	
COMPILED BY	PHOTOGRAPHER

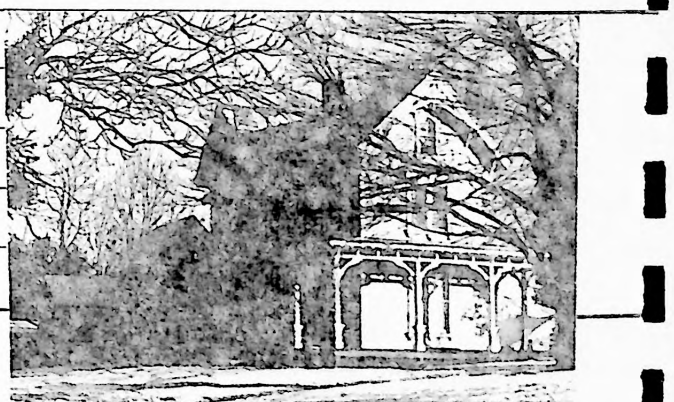
DESCRIPTION (Continued)	<p>17 OTHER NOTABLE FEATURES OF BUILDING OR SITE (interior and/or exterior)</p> <p>A cross shaped house in plan with additional elements to rear. Main gable faces west to road, other gables facing east, north and south, all at same heights, proportions and detail. Symmetrical, front facade with single pair of very tall, almost floor to ceiling windows, located at the center, ground floor, 1/1 sash. A somewhat shorter window pair, also 1/1 sash, is located directly above on the second floor and capped by a large, sloped weathering cornice finished with dentils and supported by 3 brackets. Gable light is triangular headed and 1/1. All four gables have large roof overhangs which are supported on substantial brackets, two on each side. Intersecting braces and vertical king post form the gable heads with the 4 resulting spaces infilled and cut out in a decorative tri-form pattern. Turned finials at the peaks have been recently removed. A 2 story bay window faces south and a second window pair topped with bracketed weathering cornice faces north. (Cont.)</p>

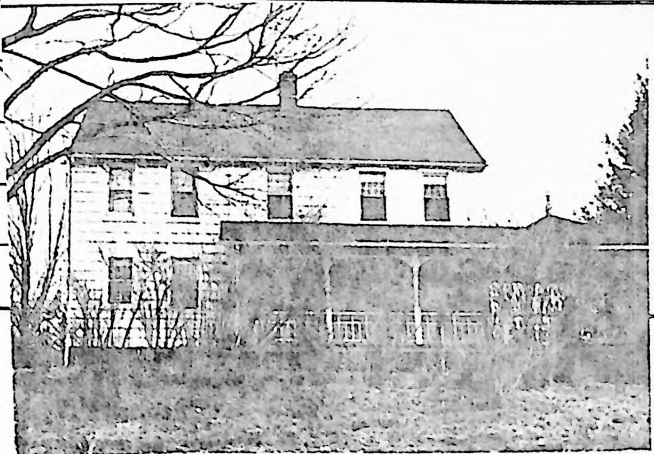
12 CONDITION (Structural)		(Exterior)	
<input type="checkbox"/> Excellent	<input checked="" type="checkbox"/> Good	<input type="checkbox"/> Fair	<input type="checkbox"/> Deteriorated
<input type="checkbox"/> Excellent	<input checked="" type="checkbox"/> Good	<input type="checkbox"/> Fair	<input type="checkbox"/> Deteriorated

13 INTEGRITY (Location)		WHEN?	(Alterations)	IF YES, EXPLAIN
<input checked="" type="checkbox"/> On original site	<input type="checkbox"/> Moved		<input checked="" type="checkbox"/> Yes <input type="checkbox"/> No	Shingle siding. Porched added c.1880. Center chimney removed, replaced by smaller one.

DESCRIPTION (Continued)	17 OTHER NOTABLE FEATURES OF BUILDING OR SITE (interior and/or exterior)	
	<p>5-bay facade, outer windows paired. Center window spaced apart. 12/12 windows.</p> <p>North gable window 12/12, south gable window altered, but was also 12/12 originally.</p> <p>Center front door surrounded -- simple, narrow, flat pilasters with simple capitals support heavy, plain entablature and wide cornice; similar to that on 29 Cedar Lake Rd.</p> <p>6/6 windows in rear ell. Granite foundation face south side of main house continues through ell.</p> <p>Front, north and rear side of main house and ell are sandstone. (see continuation sheet)</p>	
SIGNIFICANCE	18 ARCHITECTY	BUILDER
	19 HISTORICAL OR ARCHITECTURAL IMPORTANCE	
<p>An 1898 photograph of house from southwest view is hung in house.</p> <p>Probably built by Samuel Foote (1772-1849) who married Lydia Baldwin (1775-1840), daughter of Deacon Israel Baldwin.</p>

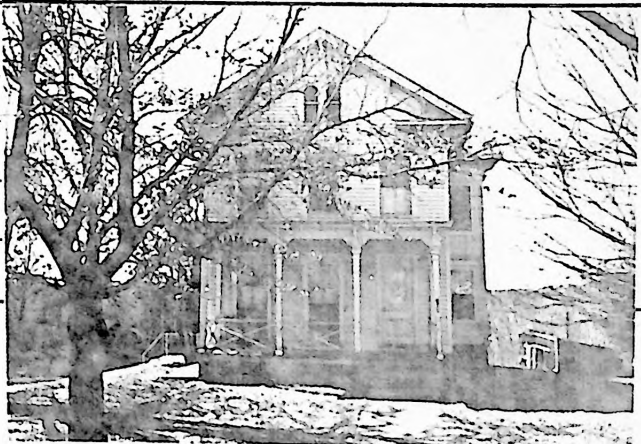
11. NUMBER OF STORIES		APPROXIMATE DIMENSIONS	
2 + attic		52' x 27'	
12. CONDITION (Structural)		(Exterior)	
<input type="checkbox"/> Excellent	<input checked="" type="checkbox"/> Good	<input type="checkbox"/> Fair	<input type="checkbox"/> Deteriorated
<input type="checkbox"/> Excellent	<input checked="" type="checkbox"/> Good	<input type="checkbox"/> Fair	<input type="checkbox"/> Deteriorated

DESCRIPTION (Continued)	17 OTHER NOTABLE FEATURES OF BUILDING OR SITE (interior and or exterior) Gable faces road. 3 bay facade. Molded cornices supported by substantial, scrolled brackets have deep returns and wide soffits. Twin, narrow, round headed gable lights at center. 2/2 window sash throughout except for two 2/4 floor to ceiling windows at the first floor front. Window and door trim is molded with sills on small brackets. Front door on right contains one large round headed light. 3 bay front porch has original square columns and capitals with scrolled bracketing. Cross braced railings not original. South side has a one story bay window-windows 2/2, a small rear porch with same detailing as front porch. Large wing to rear with exposed brick foundation-gable lower than main house. North side has a round headed, stained glass window toward front. Single, round headed light in north gable, low round headed window on wing.

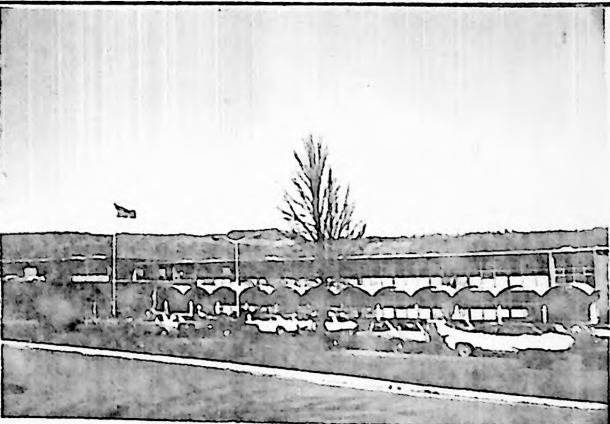
DESCRIPTION (Continued)	17 OTHER NOTABLE FEATURES OF BUILDING OR SITE (interior and or exterior)	
	<ol style="list-style-type: none"> 1. Twelve Bay, reinforced concrete arcaded canopy at front. 2. Southern-most, two story class wing designed as square in plan and turned at 45° to rest of building. Makes interesting prow like shape when approaching building from south. 	
SIGNIFICANCE	18 ARCHITECT Schilling & Goldbecker	BUILDER Marr o Construction
	19 HISTORICAL OR ARCHITECTURAL IMPORTANCE	
	<ol style="list-style-type: none"> 1. First High School in North Branford. Before it was built, high school students were sent to high schools in surrounding towns and New Haven. 2. Gym is used for Annual Town Meetings in May and other large-scale town functions. 	
SOURCES	<ol style="list-style-type: none"> 1. George Gallager 2. North Branford Board of Education 3. North Branford Assesor's Office 	
COMPILED BY	PHOTOGRAPHER Ruth Arnold 12/79

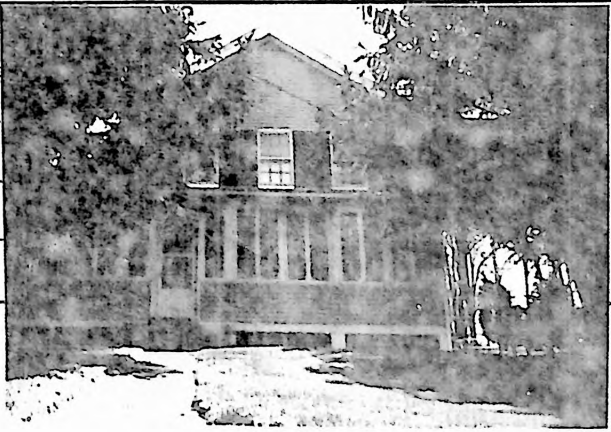
DESCRIPTION (Continued)	17 OTHER NOTABLE FEATURES OF BUILDING OR SITE (interior and/or exterior)	
	<p>Gable facing road was built with large cornice returns. There had been a horizontal window with a shallow segmental arch in the front gable. The other windows are 6/6 sash with the exception of a round headed, colored glass window on the second floor, east elevation. A side wing protrudes 5' to east. The porch had earlier been open, composed of turned columns and balusters.</p> <p>Alterations - fireplaces removed, arched doorway inserted between kitchen and dining room in 1940's; aluminum siding applied c. 1955.</p>	
SIGNIFICANCE	18 ARCHITECT	BUILDER
		James Smith
SIGNIFICANCE	19 HISTORICAL OR ARCHITECTURAL IMPORTANCE	
	<p>The owners have photographs taken in the 30's and 40's showing original shallow arched gable window and substantial cornice returns as well as surrounding landscaping. Mrs. Meiuk (current owner's mother) had a formal garden across the street in the shape of a large wagon wheel. A barn across the street was torn down in the early 1950's according to Mrs. Ann Faraone.</p>

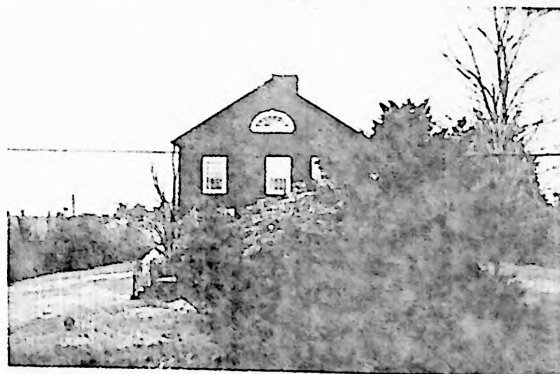
DESCRIPTION (Continued)	17 OTHER NOTABLE FEATURES OF BUILDING OR SITE (interior and/or exterior)	
	1. The interior has original doors of flush panels on one side/sunken panel on reverse. Many original latches remain. 2. Back ell is original and once contained a large fireplace. The room was converted to a kitchen around 1919. 3. Four fireplaces remain - one in the cellar and 3 on the first floor 4. The north room has detailed woodwork and appears to have been updated around 1850. The mantel is made of two fluted pilasters which in turn support an arch again of fluted pilasters which frame a simple frieze and support a 6 tiered raked cornice. 5. Plank floors through most of the house as well as plaster walls. 6. 5 window asymmetrical front with 8/12 sash on 2nd. floor and 2/2 on first. Fan window with key in gable. No closed pediment or cornice returns. 6 panel front door found by present owners in rear shed and reinstalled. <u>Classical entry surround (Cont.)</u>

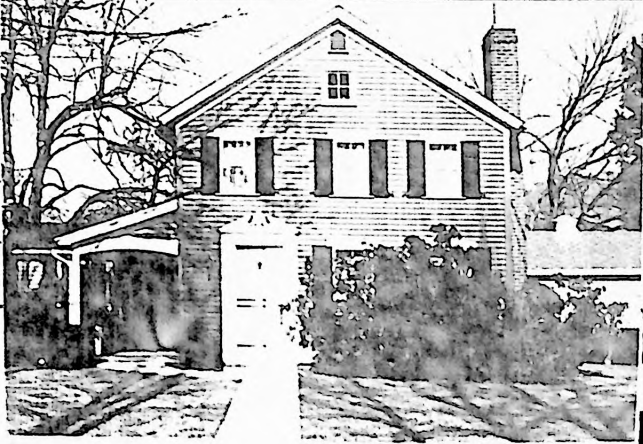
DESCRIPTION (Continued)	17 OTHER NOTABLE FEATURES OF BUILDING OR SITE (interior and or exterior)		<p>1. This was originally a Greek Revival country house of modest scale very similar to the Dudley house, 167 Sea Hill Rd. House was also located quite close to this house before being moved.</p> <p>2. It is said that both houses are constructed of ships timbers.</p> <p>3. No original exterior detail left.</p> <p>4. Grounds and barn very nice, well kept, picturesque.</p> <p>5. Remodeling has been done on second floor but some doors and latches might be original: door to bedroom and door to back room.</p> <p>6. Barn is approximately 60 years old, built for owner's father by Mr. Linsley. Is braced frame construction, wood pegs, fieldstone foundation.</p>
	18 ARCHITECT	BUILDER	
SIGNIFICANCE	19 HISTORICAL OR ARCHITECTURAL IMPORTANCE		
	<p>1. "Mulford House drawn from opposite Davis Ford's (196 Sea Hill Rd.) on other street. Repaired and occupied by Major Page."* Major Jason Page (1781-1881)</p> <p>2. House was put on old dry laid fieldstone foundation that was too big for it. Mrs. Burrone pointed it.</p> <p>3. Original house at that time had all interior partitions removed, also removed staircase, on first floor to create one large open living room. House completely remodeled in 1949 by Mrs. Burrone.</p> <p>5. Central chimney removed before Burrones moved in.</p> <p>6. Old kitchen addition to south is now a den. Granite fireplace built by owners.</p> <p>7. Old summer kitchen is now porch. Original well has been encased with granite, still has old wheel.</p> <p>8. Wood shed is laundry and bath.</p> <p>9. Paneling in den is local Conn. cedar; in enclosed patio, local pine.</p>

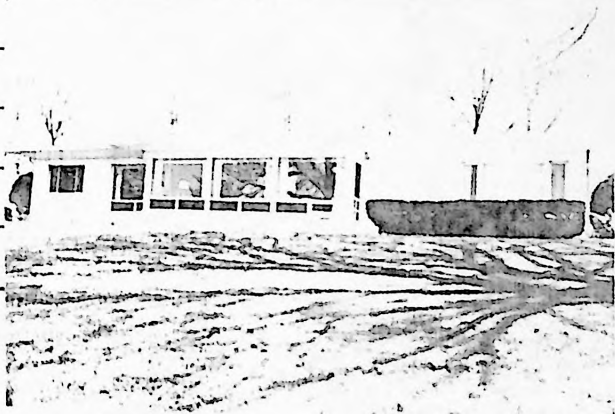
DESCRIPTION (Continued)	17 OTHER NOTABLE FEATURES OF BUILDING OR SITE (interior and/or exterior)		1. Three car garage - separate from house but linked with canopy. 2. Large, glass window wall oriented to west. Large roof overhang on this facade for sun control. 3. Row of 8 pruned apple trees along west side of drive.	
	18 ARCHITECTURE	BUILDER	Douglas Orr	
SIGNIFICANCE	19 HISTORICAL OR ARCHITECTURAL IMPORTANCE			
SOURCES	Owner			
PHOTO	PHOTOGRAPHER		5/79	
	VIEW	NEGATIVE ON FILE		
COMPILED BY	West - front		yes	
	NAME		8/15/79	
	ORGANIZATION		Totoket Historical Society, Inc.	
	ADDRESS		P. O. Box 117, Northford, CT 06472	
20 SUBSEQUENT FIELD EVALUATIONS

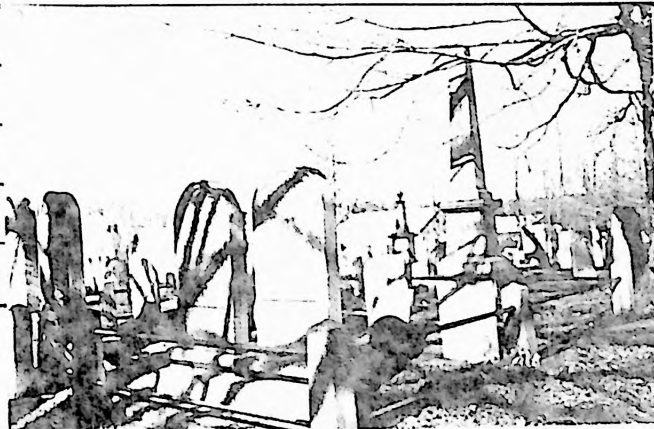
DESCRIPTION (Continued)	17 OTHER NOTABLE FEATURES OF BUILDING OR SITE (interior and or exterior)	
	18 ARCHITECTY	BUILDER
	19 HISTORICAL OR ARCHITECTURAL IMPORTANCE	
SIGNIFICANCE	<p>The old village cemetery for the Third Ecclesiastical Society of Branford (now Northford). In the north section surrounded by a sandstone wall installed by the Town of North Branford in 1849, 159 sandstone and 413 marble and granite stones survive. There are two dating from 1744; one a Bartholomew infant. The Bartholomews owned the adjoining land and the "Burying Place" is mentioned in a 1759 deed.</p> <p>The Association was incorporated in 1919 as an offshoot of the Northford Village Improvement Society since the cemetery was in a very run down condition.</p>	
	<p>Cemetery stones and Association records. Notes of Mrs. Morris Alling. Count and map of old stones made by Charlotte Miller and Gordon S. Miller, 1978</p>

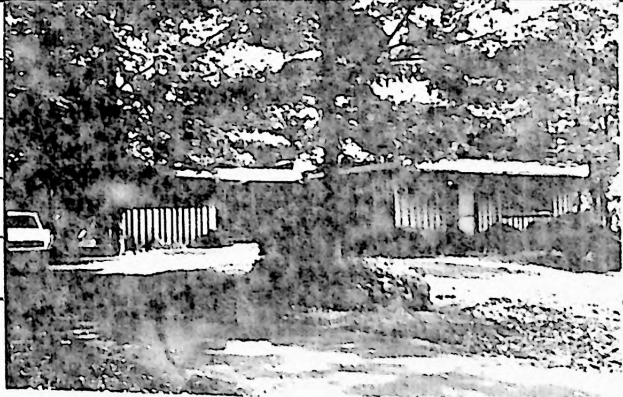
DESCRIPTION (Continued)	17 OTHER NOTABLE FEATURES OF BUILDING OR SITE (interior and or exterior) 1. I shaped plan. Entry at inside corner. 2. Cypress wood used for vertical board and batten siding and roof fascia boards, finished clear. 3. Varied roof overhangs on exterior, 10' maximum on west facade. 4. Two pair french doors open to 10' X 30' wood deck at south. 5. Massive, coursed ashlar, fieldstone fireplace at center of house. 6. Detailing, both inside and out, very delicate and well proportioned. 7. Roof structural members, 2" X 12" wood beams 4' on center, are exposed inside. 8. House is one story, exposed basement at south (two stories). Separate apartment in basement.	
	18 ARCHITECT Richard Brunjes Yale student team project	BUILDER Richard Brunjes Yale students - team project
SIGNIFICANCE	19 HISTORICAL OR ARCHITECTURAL IMPORTANCE Built by Yale University architecture students for Wilmarth Kendall. Could be considered the best example of modern architecture included in this 1980 survey in terms of both design and execution.*

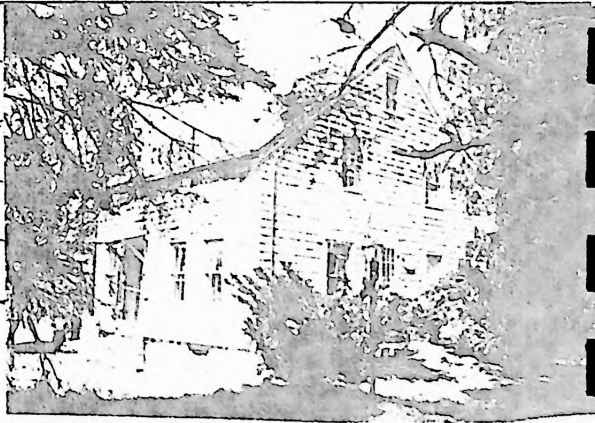
DESCRIPTION (Continued)	<p>17 OTHER NOTABLE FEATURES OF BUILDING OR SITE (interior and/or exterior)</p> <p>Large off-center chimney still intact although in very poor condition. Original kitchen fireplace (now blocked up) was in cellar.</p>			
	<p>18 ARCHITECT</p> <p style="text-align: center;">-</p>		<p>BUILDER</p> <p style="text-align: center;">-</p>	
SIGNIFICANCE	<p>19 HISTORICAL OR ARCHITECTURAL IMPORTANCE</p> <p>Rare survivor of a very small simple country house, never enlarged. Several partitions downstairs removed or altered. Some beaded board partitions and batten doors still on second floor.</p> <p>Probably built by the Peter Tyler who lived from 1765-1842.</p>			
SOURCES	<p><u>W.P.A. Survey</u>; 1852 County Map - "P. Tyler"; Northford Cemetery records. County Map 1856.</p> <p>Beers Map 1868.</p>			
COMPILED BY	<p>PHOTOGRAPHER</p> <p>Ruth Arnold</p>		<p>DATE</p> <p>5/1979</p>

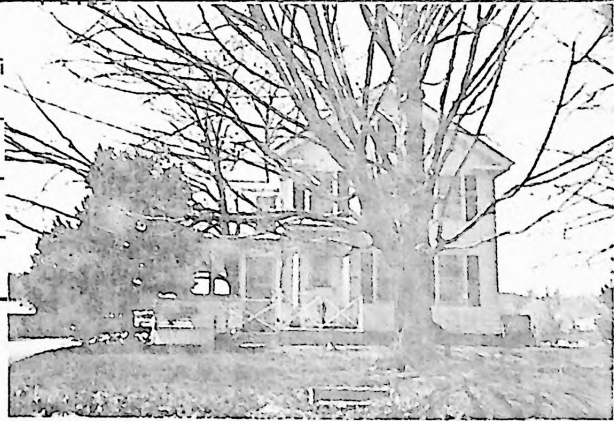
DESCRIPTION (Continued)	17 OTHER NOTABLE FEATURES OF BUILDING OR SITE (interior and/or exterior) House very similar to the Eliason house across the road about 1/4 mile north built by Charles Foote's brother a few years later. Typical country farmhouse. Attic gable window round headed (east side), 6/6. On south side, bay has round attic window. Deep cornice returns at gables. Square, chamfered columns on plinths support bracketed portico. 6/6 window sash.	
	18 ARCHITECT 	BUILDER
SIGNIFICANCE	19 HISTORICAL OR ARCHITECTURAL IMPORTANCE Deacon Charles Foote (1815-1886) was the son of Edwin Foote who owned the old farm just north across the road.	
	SOURCES Beers Atlas, 1868	
COMPILED BY	PHOTOGRAPHER Ruth Arnold 4/79	
	VIEW east-front	NEGATIVE ON FILE yes
	NAME Elizabeth A. Livingston 2/1/80	
	ORGANIZATION Totoket Historical Society, Inc.	
ADDRESS P. O. Box 117, Northford, CT 06472

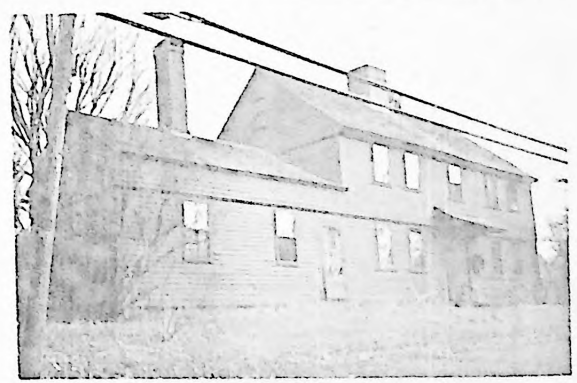
PHOTO	PHOTOGRAPHER	
	Robert Van Nest 1977	
COMPILED BY	VIEW	
	Front	
	NEGATIVE ON FILE	
	yes	
	NAME	
	Elizabeth A. Livingston 2/10/80	
	ORGANIZATION	
	Totoket Historical Society, Inc.	
	ADDRESS	
	P. O. Box 117, Northford, CT 06472

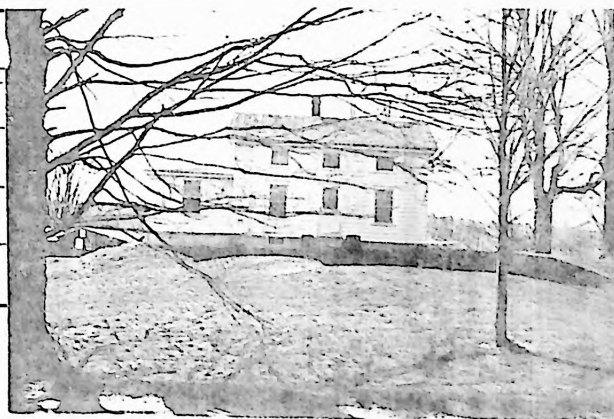
8. MATERIAL(S) (Indicate use or location when appropriate)				
<input checked="" type="checkbox"/> Clapboard	<input checked="" type="checkbox"/> Asbestos Siding	<input checked="" type="checkbox"/> Brick	<input type="checkbox"/> Other (Specify) _____	
	Over clapboard	2 chimneys		
<input type="checkbox"/> Wood Shingle	<input type="checkbox"/> Asphalt Siding	<input checked="" type="checkbox"/> Fieldstone	wing-foundation	
<input type="checkbox"/> Board & Batten	<input type="checkbox"/> Stucco	<input type="checkbox"/> Cobblestone		
<input type="checkbox"/> Aluminum Siding	<input type="checkbox"/> Concrete Type: _____	<input checked="" type="checkbox"/> Cut stone	sandstone foundation

11. NUMBER OF STORIES		APPROXIMATE DIMENSIONS		
2 + attic		37' x 28' + 2 sheds & 2 attached outhouses		
12. CONDITION (Structural)				
<input type="checkbox"/> Excellent	<input checked="" type="checkbox"/> Good	<input type="checkbox"/> Fair	<input type="checkbox"/> Deteriorated	(Exterior)
<input type="checkbox"/> Excellent	<input checked="" type="checkbox"/> Good	<input type="checkbox"/> Fair	<input type="checkbox"/> Deteriorated

DESCRIPTION (Continued)	17 OTHER NOTABLE FEATURES OF BUILDING OR SITE (interior and/or exterior)	
	1. "Palladium" type rectangular window center front, second floor - 12/12 with 6 side lights at each end. 2. 9 Window fenestration, 12/12, 2 attic fanlight windows. 3. House is virtually unchanged. Owners have had enough money to keep it in good repair-but not "change" it. Original doors, hardware (closed butt hinges) window glass. First floor ceilings about 7' 6". Porch added c. 1890. Interior doors have recessed panels on back, flush beaded panels on front. Modern flooring downstairs in main rooms - possibly over original. 4. <u>First floor</u> : Central hall. Original staircase with nice bannister. Front door replaced. N. E. Room - Federal fireplace with dentiling - 2 columns possibly replacements, no corner posts. (Cont.)	
SIGNIFICANCE	18 ARCHITECT	BUILDER
	19 HISTORICAL OR ARCHITECTURAL IMPORTANCE

SOURCES	1. Only house in Northford with 2 interior chimneys. 2. Purchased Nov. 1817 by Stephen Tyler from Susanna Harrison.	
	WPA records Branford Land Records 18-63 No. Branford Land Records County Maps 1852-1856 Beers Atlas 1868	
PHOTO	PHOTOGRAPHER Ruth Arnold 1/80	
	VIEW left front	NEGATIVE ON FILM yes
COMPILED BY	NAME Helen H. Livingston 3/17/80	
	ORGANIZATION Totoket Historical Society, Inc.	
	ADDRESS P. O. Box 117, Northford, CT 06472	
20 SUBSEQUENT FIELD EVALUATIONS

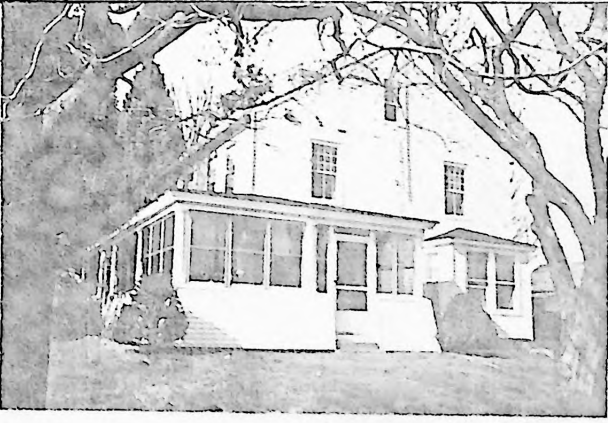
DESCRIPTION (Continued)	17 OTHER NOTABLE FEATURES OF BUILDING OR SITE (interior and/or exterior)	
	<p>Interior Downstairs: S. front room modern brick fireplace with orig. Federal mantel and molding. N. front room 3 oval reeded paterae, 2 pr. vertical reeded pilasters - Adam style replaced mantel shelf. Original kitchen fireplace closed up. Piece of mantel shelf remains. S. front room still has chair rail. Wide beaded, boxed corner posts in most rooms. Orig. kitchen-narrow beaded horizontal wainscoting.</p> <p>Upstairs: Front stairs in orig. location - narrow and steep. Palladian-type window 12/12 sash with sidelights - old glass but no old trim. 2nd. floor finished off after 1916 - some old flooring. Attic stairs removed. Backroom ceiling and walls narrow match boarding. No fireplaces upstairs.</p>	
SIGNIFICANCE	18 ARCHITECT	BUILDER Foote
	19 HISTORICAL OR ARCHITECTURAL IMPORTANCE	
SOURCES	<p>Rectangular Palladian window center front 2nd. floor. 12/12 sash second floor. 2/2 ground floor. Porch added after 1900. Roof has slight up-turn at front and rear plate. Road originally nearer house.</p>

<p>W.P.A. survey N. B. Assesor's office 1868, 1856, 1852 maps Interview with owner.</p>	
PHOTO	PHOTOGRAPHER Ruth Arnold	5/79
	VIEW Front	NEGATIVE ON FILM Yes
COMPILED BY	NAME Helen H. Livingston	2/29/80
	ORGANIZATION Totoket Historical Society, Inc.	
	ADDRESS P. O. Box 117, Northford, CT 06742	
20 SUBSEQUENT FIELD EVALUATIONS
