The Historical and Architectural
Survey of North Branford

Part E

Prepared by
Totoket Historical Society, Inc.
under the direction of
Frank J. Pannenberg

May 1980

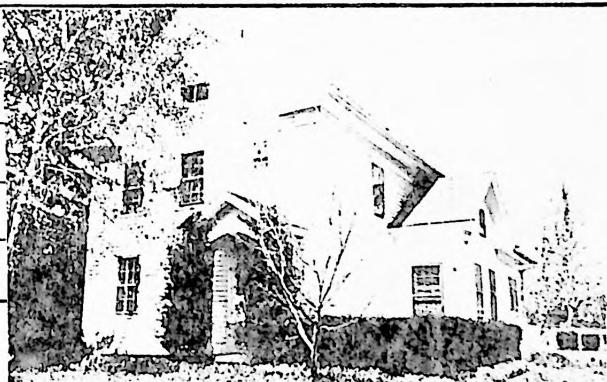
Item # **201**

DESCRIPTION (Continued)	17 OTHER NOTABLE FEATURES OF BUILDING OR SITE (interior and/or exterior)		
	1. Gable end to road. Wide eaves and cornice with deep returns. 2. Horizontal window (altered?) in front gable. 3. Italianate portico with square, chamfered columns on pedestals over simple Greek Revival front door. 4. Three-bay facade; side hall plan. 6/6 windows.		
SIGNIFICANCE	18 ARCHITECT	BUILDER	
	19 HISTORICAL OR ARCHITECTURAL IMPORTANCE Possibly built by the Fowler family. The Amos Harrison family had a sawmill on the stream nearby.		
SOURCES	Beers Atlas 1868 Mrs. Morris Alling's notes (THS files)		
COMPILED BY PHOTO	PHOTOGRAPHER Ruth Arnold		
	VIEW Front	6/79 NEGATIVE ON FILE yes	
	NAME Elizabeth A. Livingston		
	ORGANIZATION Totoket Historical Society, Inc.		
ADDRESS P. O. Box 117, Northford, CT 06472			
20 SUBSEQUENT FIELD EVALUATIONS			
<div style="display: flex; align-items: center;">

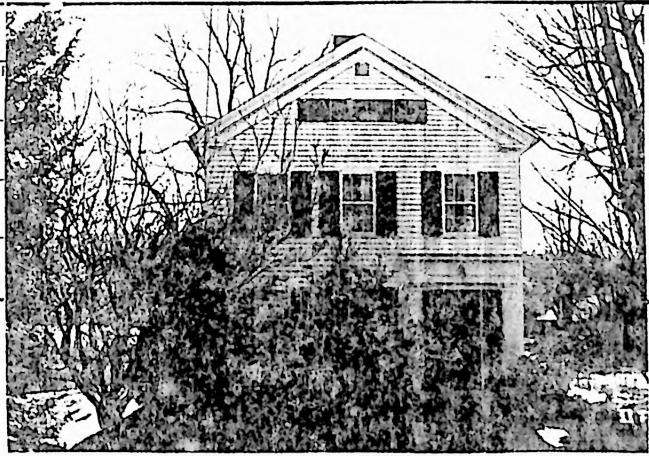
DESCRIPTION (Continued)	17 OTHER NOTABLE FEATURES OF BUILDING OR SITE (interior and/or exterior)		
	<ol style="list-style-type: none"> 1. Central chimney - rear room fireplace is paneled above. Has oven with elaborately designed iron door. 2. Original front staircase. 3. Front room has been remodeled recently-walls covered with pine paneling. 4. Interior wall has been removed between two rear rooms. Original rear stairway. 5. Vertical paneled interior doors are original. Original latches had been replaced with porcelain knobs. Owners replaced with facsimiles of originals. 6. Bay window and rear porch added, probably about 1880. 7. Rear ell originally was 2 rooms, pantry & sink room. Interior wall was removed and ell was extended to make large country kitchen. Contains old porcelain sink & standing wooden cupboards- (Cont.) 		
SIGNIFICANCE	18 ARCHITECT	BUILDER	
		By/for Washington Gordon	
	19 HISTORICAL OR ARCHITECTURAL IMPORTANCE

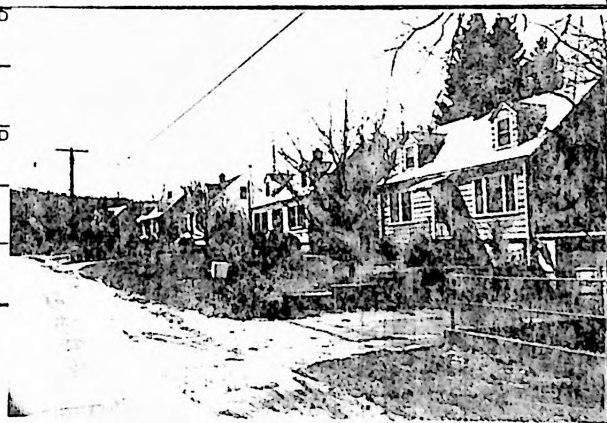
DESCRIPTION (Continued)	17 OTHER NOTABLE FEATURES OF BUILDING OR SITE (interior and/or exterior)	
	1) Sunset I contains 30 houses. Sunset II contains 64. 2) Basic model is Colonial in style with 2 dormers facing street and central entries with classical references. 3) In Sunset I, 10 of the 30 lots were sold to the Cascade Company, a development branch of the DeForest and Hotchkiss Lumber Company of New Haven. The houses built on these lots were prefabricated "Homola" units.	
SIGNIFICANCE	18 ARCHITECT Samuel Gitlitz - original design, modified by Scanio J. Riccio	BUILDER Arthur R. & Edward F. Riccio
	19 HISTORICAL OR ARCHITECTURAL IMPORTANCE <ol style="list-style-type: none"> 1) First tract, housing development in North Branford and Northford. 2) Interesting example of individual owners asserting their own tastes by way of exterior changes to what were originally standardized houses stamped out by a cookie cutter. 3) Land was owned by Linsley Family from the time of earliest English settlement of area. Was sold to Riccio's by Mrs. Daniel M. Dody who is a Linsley descendent. 4) Engineer was Charles Miller. His work included road layouts, drainage system, staking out foundations. He did much work on other subdivisions in this area. 5) One of the first G.I. loan and F.D.A. subdivisions in this area.

SOURCES	North Branford Assessor's Office. Arthur R. Riccio - Builder.	
COMPILED BY	PHOTOGRAPHER Ruth Arnold 3/79	
	VIEW Looking southwest-Arthur Rd. Yes	
	NAME Frank J. Pannenburg 11/14/79	
	ORGANIZATION Totoket Historical Society, Inc.	
	ADDRESS P.O. Box 117, Northford, CT 06472	
20 SUBSEQUENT FIELD EVALUATIONS		
<div style="display: flex; justify-content: space-between;"> <div> 21 THREATS TO BUILDING OR SITE <input checked="" type="checkbox"/> None known <input type="checkbox"/> Highways <input type="checkbox"/> Vandalism <input type="checkbox"/> Developers <input type="checkbox"/> Other _____ </div> <div> <input type="checkbox"/> Renewal <input type="checkbox"/> Private <input type="checkbox"/> Deterioration <input type="checkbox"/> Zoning <input type="checkbox"/> Explanation _____ </div> </div>

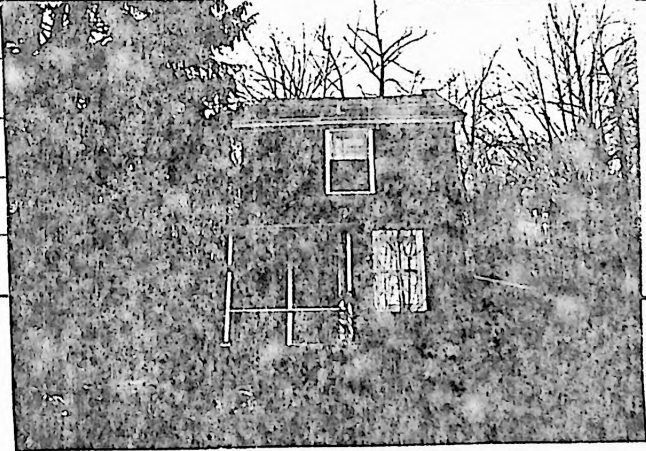
DESCRIPTION (Continued)	17 OTHER NOTABLE FEATURES OF BUILDING OR SITE (interior and or exterior)	
	<p>North and south gable end profiles resemble those of a typical, large Greek Revival house. The 1 bay, east-west profile is far from typical. A unique, one of a kind house in this survey. 6/6 windows. Recently aluminum sided.</p>	
SIGNIFICANCE	18 ARCHITECT	BUILDER
	19 HISTORICAL OR ARCHITECTURAL IMPORTANCE	
<p>Built on site of older house, burned c. 1935.</p>		
SOURCES	<p>Augur, Edwin P. (Compiler) Family History and Genealogy of the Descendants of Robert Augur N. B. Land Records, V-132, Apr. 23, 1864 *Phone call to Mrs. Joseph C. Augur 3/26/80</p>	
PHOTO	PHOTOGRAPHER	5/79
	VIEW	NEGATIVE ON FILE
COMPILED BY	NAME	yes
	ORGANIZATION	
	ADDRESS	
20 SUBSEQUENT FIELD EVALUATIONS

<p>Recently aluminum sided.</p>		
21 THREATS TO BUILDING OR SITE		
<input type="checkbox"/> None known <input type="checkbox"/> Highways <input type="checkbox"/> Vandalism <input type="checkbox"/> Developers <input type="checkbox"/> Other _____

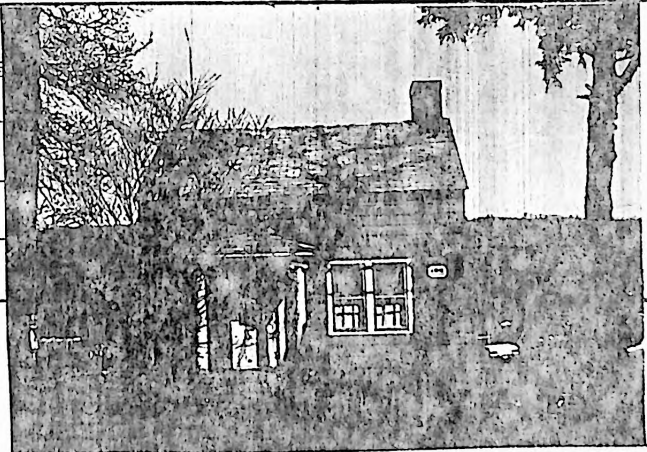
DESCRIPTION (Continued)	17 OTHER NOTABLE FEATURES OF BUILDING OR SITE (interior and/or exterior)	
	<p>House had deteriorated badly. Interior thoroughly changed. Modern fiberboard-type panelling installed. Originally had 3 fireplaces-1 in front downstairs and 2 in wing-1 up and kitchen on ground floor. All fireplaces now boarded up. (2)</p> <p>Portico supported by 2 fluted Ionic wood columns-nice detail. Very low pitch to portico roof. Windows on front 2-paired. No upstairs front windows.</p> <p>Chimney in main part of house set slightly in from S. gable end. Chimney also in back wing. Back wing probably contemporary to house. Most windows 6/6. One 12/12 at rear ground level. Two 1/1 at rear 2nd level.</p> <p>Two old barns, one with cupola.</p>	
SIGNIFICANCE	18 ARCHITECT	BUILDER
		Probably Harvey Augur
SIGNIFICANCE	19 HISTORICAL OR ARCHITECTURAL IMPORTANCE	
	<p>Harvey Augur (1794-1882) son of Peter, Sr. married Lydia Robinson in 1820 or 23.</p> <p>A part of his land on the east side of the west road (i.e. Totoket Rd.) was a portion of "The King's Farm" bequeathed by...grandfather John. (3)</p> <p>Harvey was a carpenter by trade and later a farmer. (1)</p>

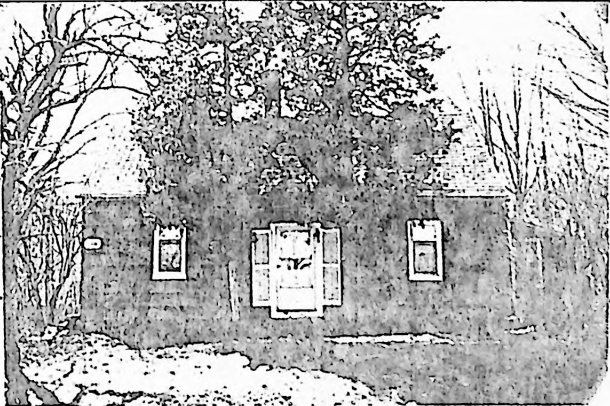
DESCRIPTION (Continued)	17 OTHER NOTABLE FEATURES OF BUILDING OR SITE (interior and or exterior)	
	1 $\frac{1}{2}$ story saltbox. "Coffin" door on south side. Small central chimney - no fireplaces. 2 small, narrow windows flank center entry. Some cased corner posts.	
SIGNIFICANCE	18 ARCHITECT	BUILDER
	19 HISTORICAL OR ARCHITECTURAL IMPORTANCE Most likely built by Salmon Robinson, father of the Uriah Robinson who ran the saw mill on Farm River at Mill Rd. House in Robinson family for 2-3 generations until 1912. Barns have been demolished.	
SOURCES	Beers Atlas 1868-S. Robinson County Maps 1856 & 1852-house shows, but no names listed N. B. Land Records *Conversation with owner.	
PHOTO	PHOTOGRAPHER	4/79
	VIEW	NEGATIVE ON FILE
COMPILED BY	Front	yes
	NAME	
	ORGANIZATION	3/23/80
	ADDRESS	
20 SUBSEQUENT FIELD EVALUATIONS

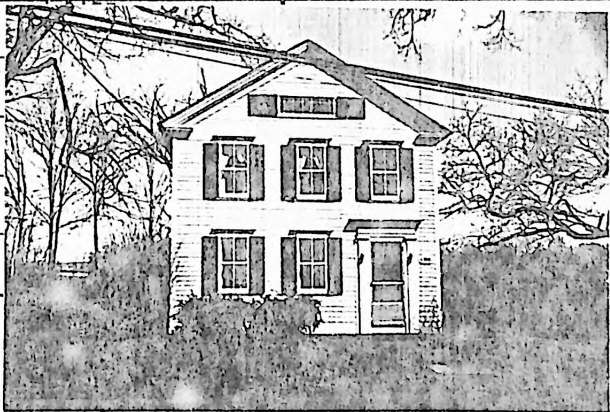
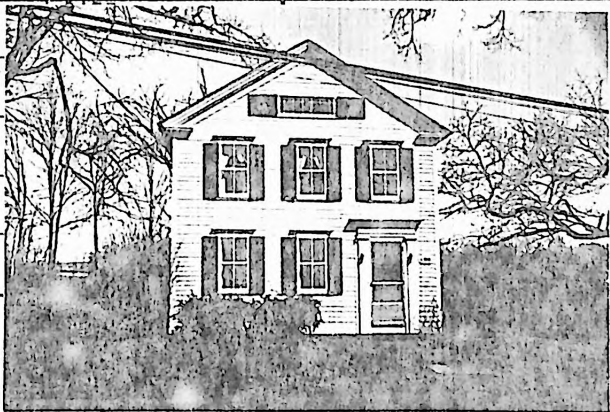
DESCRIPTION (Continued)	17 OTHER NOTABLE FEATURES OF BUILDING OR SITE (interior and/or exterior)		<p>Smoke oven in attic on E. side of chimney door has leather top hinge (broken). Attic roofers smoked farm oven usage. Fired brick used for oven. Plate 6"-8" above floor. Canted braces to purlains-straight sawn. Plastered on wall under plate N. & S. sides. Ridge pole very small. West multi paned, horizontal gable window - large panes - 9 x 11. Narrow beading on corner posts. No foundation under wing which still has dug well in floor. Cellar-2 rectangular fieldstone piers for chimney. Cribbing for front and back fireplaces (1 gone) still shows. Wide cornice and return on front gable. Fine dentilling over front door under entablature. <div style="text-align: right;">(Cont.)</div> </p>
	18 ARCHITECT	BUILDER	
SIGNIFICANCE	19 HISTORICAL OR ARCHITECTURAL IMPORTANCE		
	<p>Been in Page family since 1845 when Judson Page purchased it from George Bunnell.²</p>

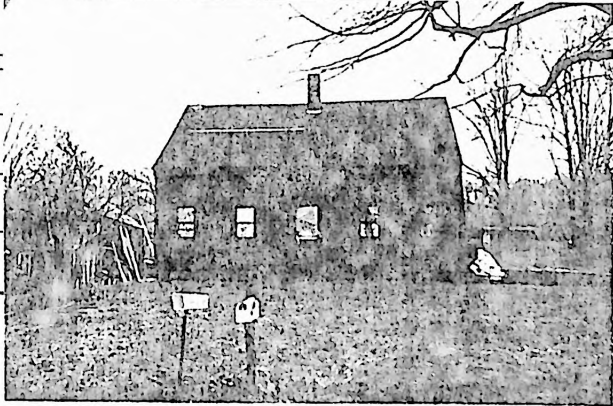
DESCRIPTION (Continued)	17 OTHER NOTABLE FEATURES OF BUILDING OR SITE (interior and or exterior) Original center chimney replaced by small one set to front of roof ridge. Windows replaced. Barn (26' x 46') to rear in poor condition. House is presently being remodeled.	
	18 ARCHITECT	BUILDER
SIGNIFICANCE	19 HISTORICAL OR ARCHITECTURAL IMPORTANCE A. Frisbie first lived here and kept a store, then, the Linsleys bought it. Mr. Rufus Linsley lived here before 1800. House passed to his son Livi.* One of two old houses remaining on southern portion of Totoket Rd.	
	SOURCES *Martha Russell's <u>Notes</u> Beers Atlas 1868 County Map 1852	
COMPILED BY	PHOTOGRAPHER Ruth Arnold 6/79	
	VIEW Front	NEGATIVE ON FILM yes
	NAME Helen H. Livingston 3/80	
	ORGANIZATION Totoket Historical Society, Inc.	
ADDRESS P. O. Box 117, Northford, CT 06472		
20 SUBSEQUENT FIELD EVALUATIONS		
<div style="display: flex; align-items: center;">

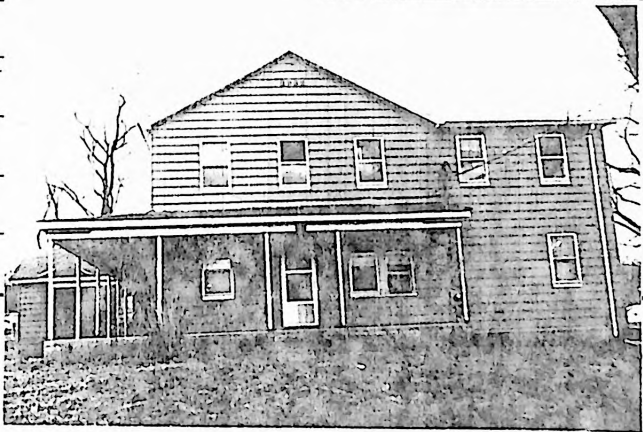
DESCRIPTION (Continued)	17 OTHER NOTABLE FEATURES OF BUILDING OR SITE (interior and or exterior)	
	<p>Completely altered and added to. Now a multi-family dwelling. It was a simple Greek Revival, gable end to road, before accretions & alterations. Main entry was originally at left of street facade with ½ mill stone door step. (1) Old fieldstone retaining wall.</p>	
SIGNIFICANCE	18 ARCHITECTY	BUILDER
	19 HISTORICAL OR ARCHITECTURAL IMPORTANCE	
<p>1. House built by/for Frederick W. Beers, grandson of Wheeler Beers. His daughter, Adelaide, married Lewis Talmadge. Wheeler Beers built first house here in mid 1700's.</p>		
SOURCES	Assessor's record 17-21 Martha Russell's Notes County Maps 1852 & 1856 (F. W. Beers) Beers Atlas 1868 (L. Talmadge) (1) Talk with Florence Juniver	
COMPILED BY	PHOTOGRAPHER Ruth Arnold	
	6/79	
	VIEW Front	NEGATIVE ON FILM yes
	NAME Janet S. Gegan	
	ORGANIZATION Totoket Historical Society, Inc.

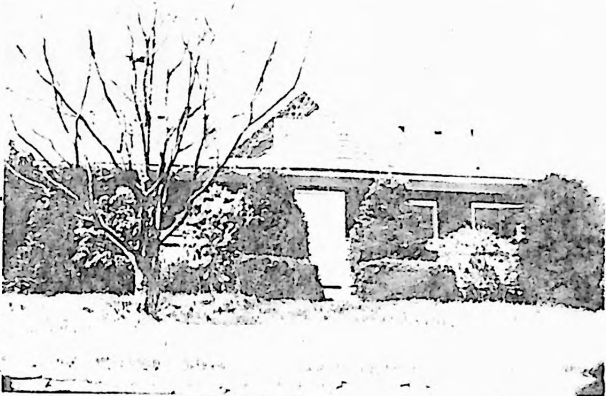
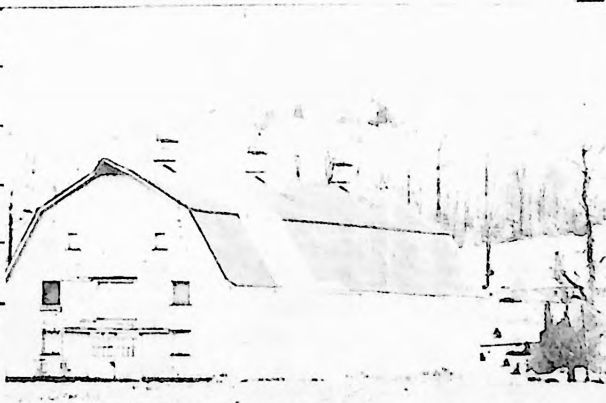
DESCRIPTION (Continued)	17 OTHER NOTABLE FEATURES OF BUILDING OR SITE (interior and or exterior)		1. Original house burned about 1910 and present house rebuilt using some remnants of older one. 2. In northeast corner of north room (in 1960) was a mid-18th century round-arched paneled door corner cupboard with fluted "keystone". In same room a cobblestone fireplace. 3. Large dairy barn, now unused as land has gone into development, built when the Durants owned the farm.	
	18 ARCHITECT		BUILDER	
SIGNIFICANCE	19 HISTORICAL OR ARCHITECTURAL IMPORTANCE			
	One of the Fowler houses in White Hollow.			
SOURCES	County Map 1852-1856 Beers Atlas - Guilford - 1868 THS file photos 1960 Mrs. Morris Alling's notes (THS files)

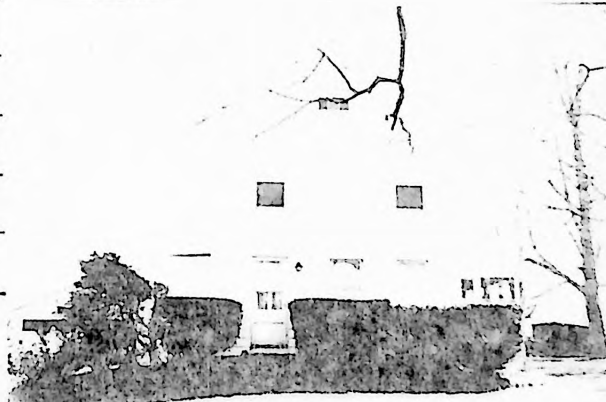
DESCRIPTION (Continued)	17 OTHER NOTABLE FEATURES OF BUILDING OR SITE (interior and or exterior)	
	Aluminum siding has destroyed any architectural details. Small 3 pane rectangular window in north gable.	
SIGNIFICANCE	18 ARCHITECT	BUILDER
	19 HISTORICAL OR ARCHITECTURAL IMPORTANCE Unnamed on County Maps of 1852 & 1856, but most likely was one of the Fowler houses in White Hollow. All the Fowler houses were painted white - thus the name. It is across from the site of the Josiah Fowler's house who in the 1790 U. S. census had three slaves for a household ^{of} only five.	
SOURCES	County Map 1852 - 1856 Beers Atlas - Guilford 1868	
COMPILED BY	PHOTOGRAPHER Ruth Arnold 5/79	
	VIEW Front	NEGATIVE ON FILE yes
	NAME Elizabeth A. Livingston 3/80	
	ORGANIZATION Totoket Historical Society, Inc.	
	ADDRESS P. O. Box 117, Northford, CT 06472	
20 SUBSEQUENT FIELD EVALUATIONS		
<div style="text-align: right;">
